p-CAT™

Pipeline Condition Assessment Technique for Water and Sewer Mains

Dr Young-il Kim
Project Director of Detection Services Pty Ltd

Water NZ 2017

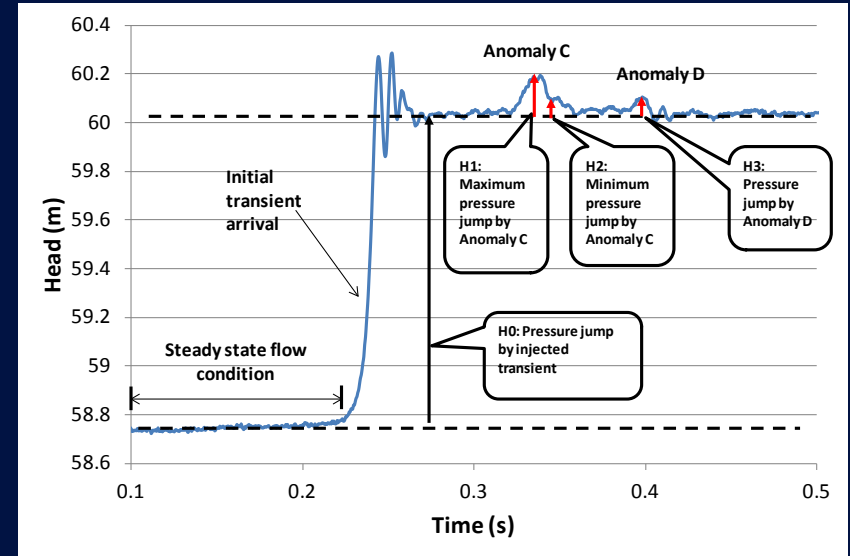
Fundamental Physical Mechanisms

- There is a correlation between changes in the thickness of metal and cement mortar lining forming a pipeline wall and the speed with which a wavefront from a hydraulic transient propagates along the pipeline.
- Changes in this thickness give rise to reflections which can be theoretically interpreted to obtain a distribution of damage in the pipe.
- Pipe wall damage or lining loss has a visible impact on a resultant transient pressure wave trace

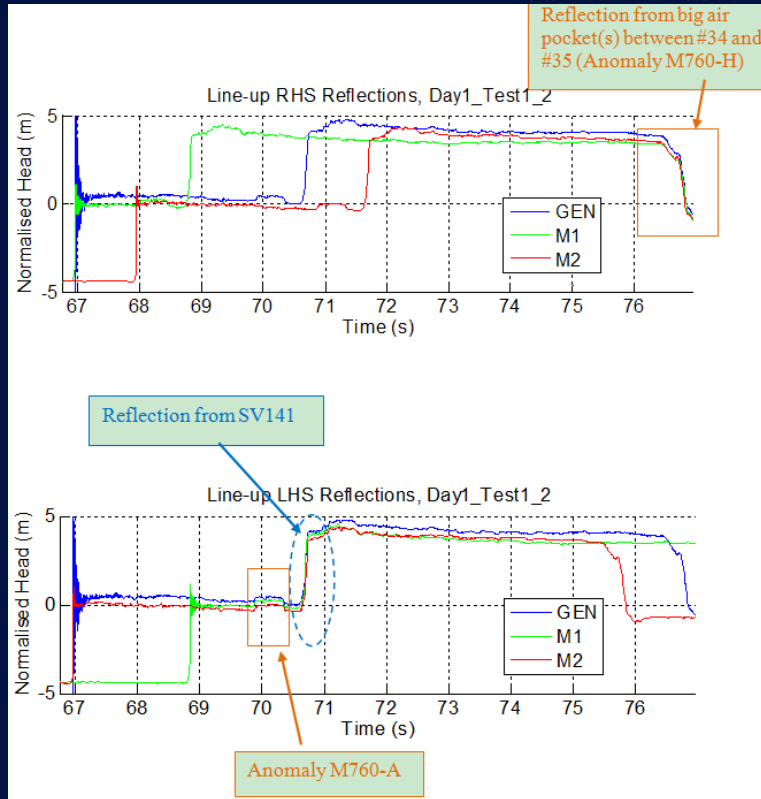
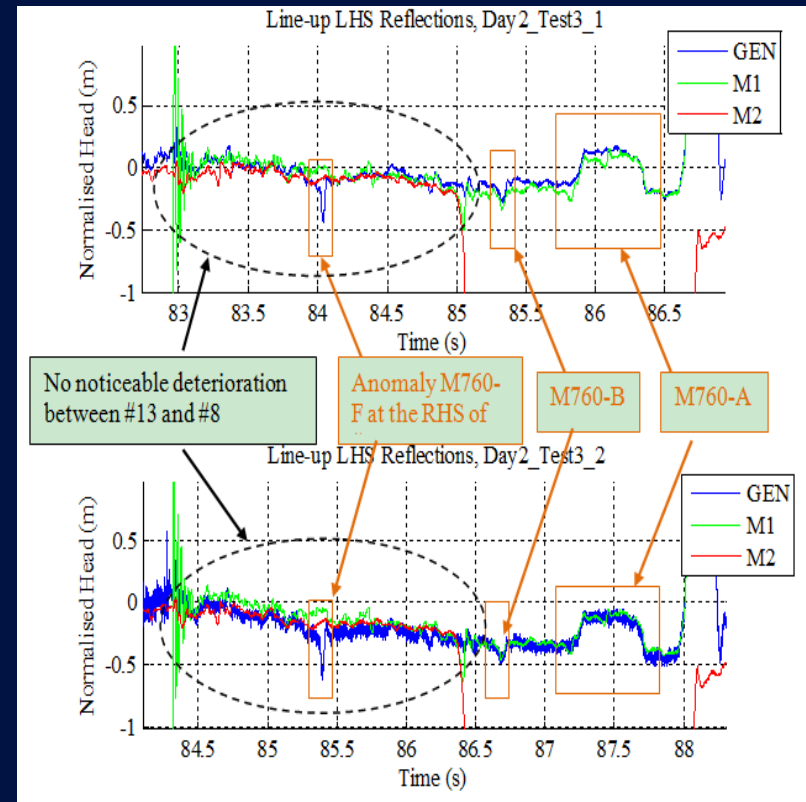
Example Field Signals

Major Boundary Reflection, Wall Thickness/Material Change and Localized Fault

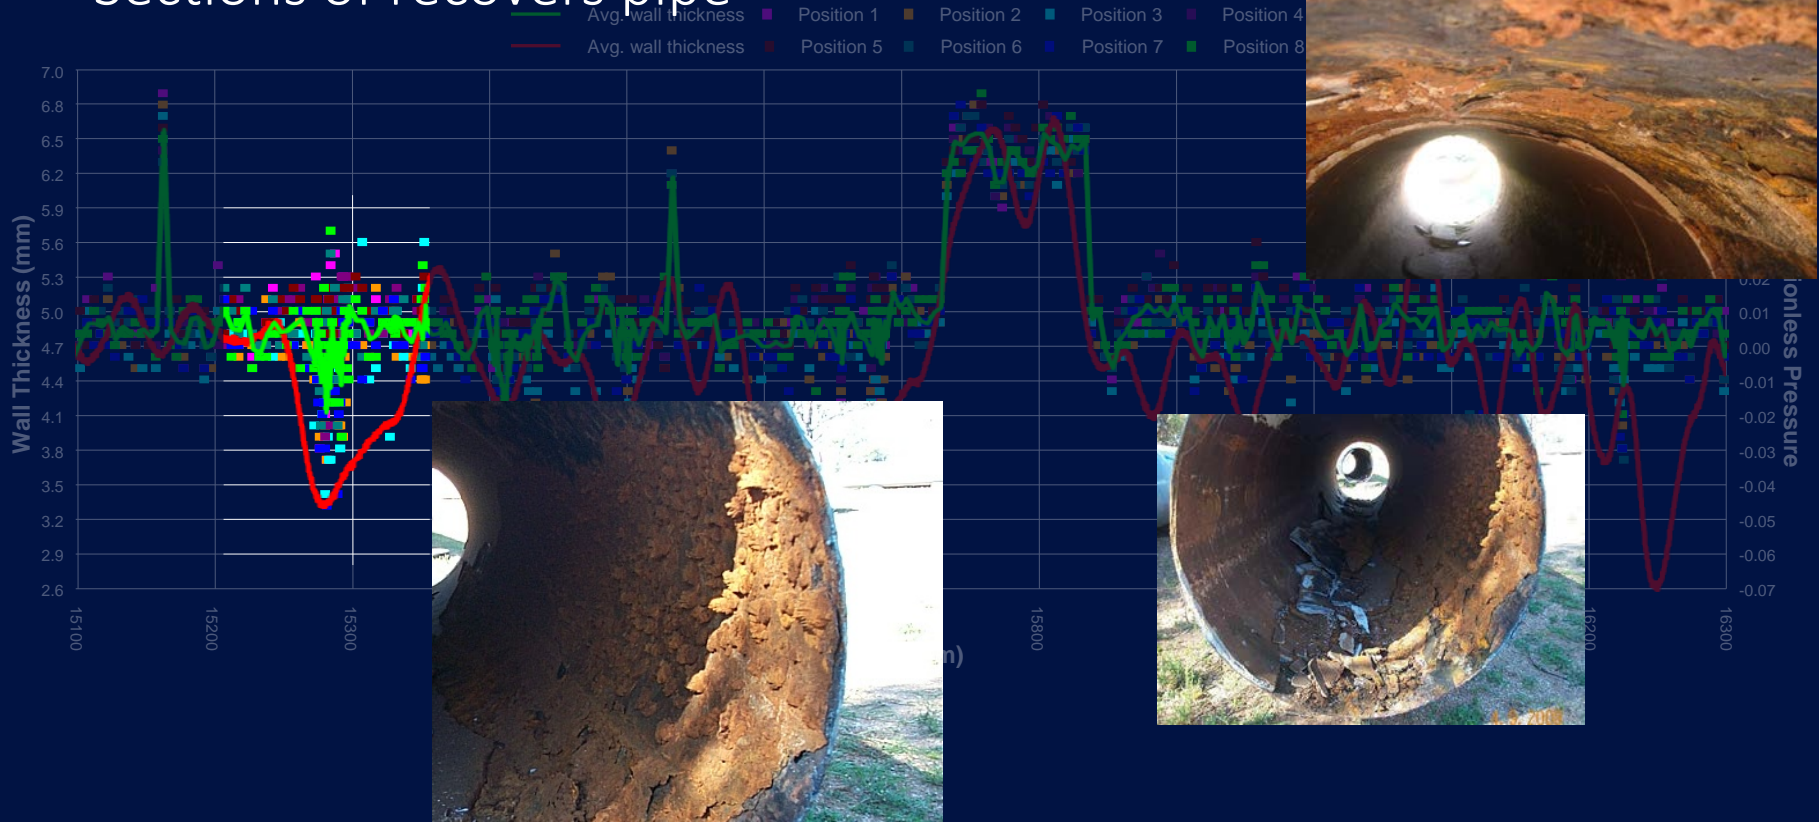
Sections of recovers pipe

Verification of Technique

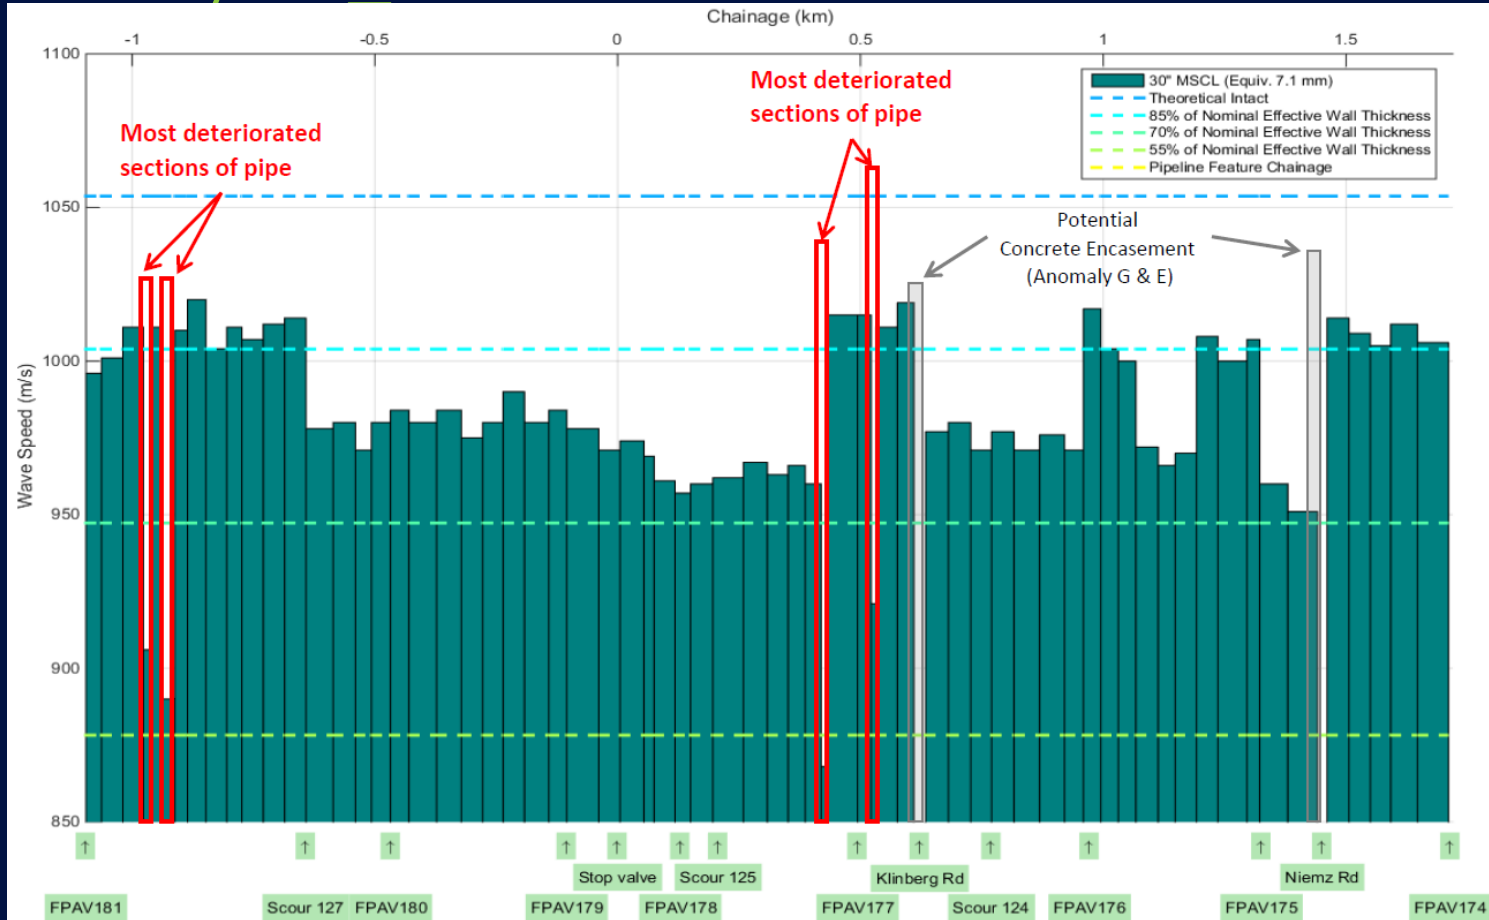
Case Study #1 Water Main

- 2% of the pipeline was found to be in the most deteriorated condition with a remaining wall thickness of between 50% and 64%.
- 68% of the pipeline showed to have some deterioration with a remaining wall thickness of between 70% and 84%.
- The rest of the pipeline (29% of the total length) has remaining wall thicknesses of between 85% and 90%.

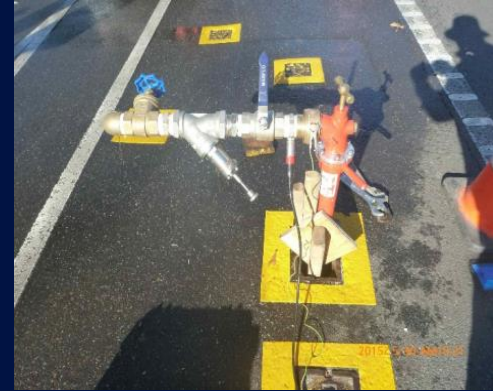
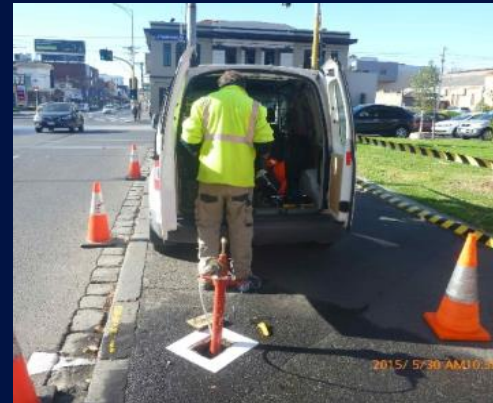
Case Study #2_Water Main

- The tests undertaken on this pipeline were conducted as part of a condition assessment project for a system in a busy CBD area. This particular section was one of two parallel pipelines following a busy main road into the city.
- The 450 CI(CL) water main was constructed from 450 CI in 1886 and later concrete lined in-situ in 1982. The pipe section of interest was 2.8 km and contains two replacement sections of 450 MSCL.

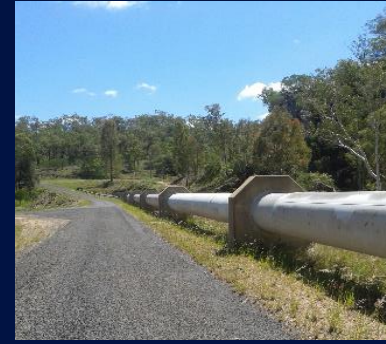
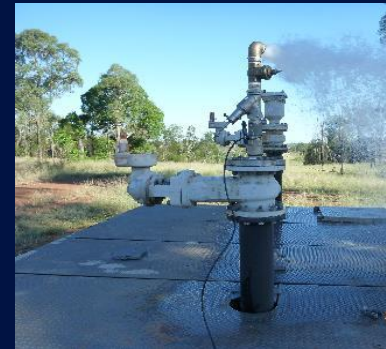
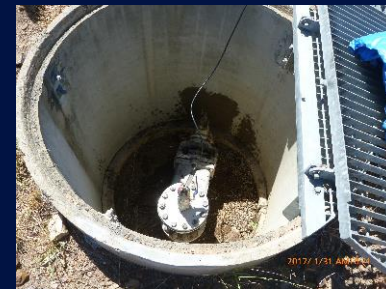
Case Study #3_Water Main

- The pipeline of interest is the first 10 km of the 23.5 km long rising main beginning at a dam pump station. The water rising main was constructed of MSCL, with a 1085 mm outside diameter.
- For the sections with an original wall thickness of 8 mm:
 - 1.7% of the length of the pipeline was found to have the highest deterioration with remaining wall thickness of between 67% and 80%.
 - 9% of the pipeline showed to have remaining wall thickness of between 80% and 90%.
- Fourteen anomalies representing:
 - The presence of a blockage or partially closed isolation valve at an isolating valve pit at 12.11 km.
 - Four short lengths of deterioration or replacement of lower wave speed pipe material.
 - Four short lengths of deterioration, replacement of lower wave speed pipe material, or branch of a known pipe feature
 - Five potential concrete encasement sections or the presence of a blockage.

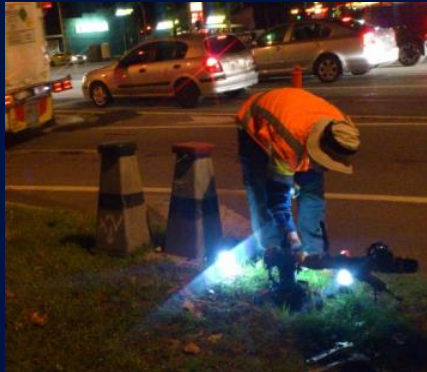
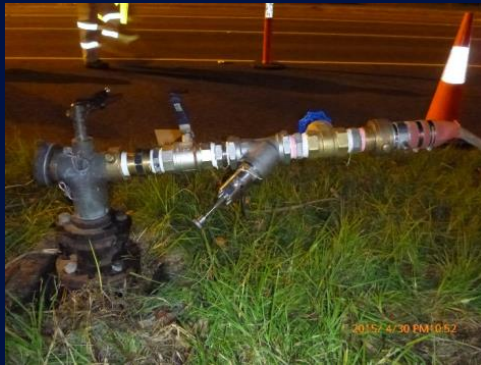
Case Study #4_ Water Main

The trunk water main consists of the following various pipe materials and sizes, including some sections with in-situ cement lining:

- 450 and 525 Wrought Iron (WI) constructed in 1893
- with in-situ cement lining added in 1953.
- 600, 700 and 825 Mild Steel Cement Lined (MSCL) constructed in 1979.
- 450 Cast Iron (CI), 600 WI and 600 Mild Steel Locking Bar (MSLB) constructed in 1916 with in-situ cement lining added in 1983.

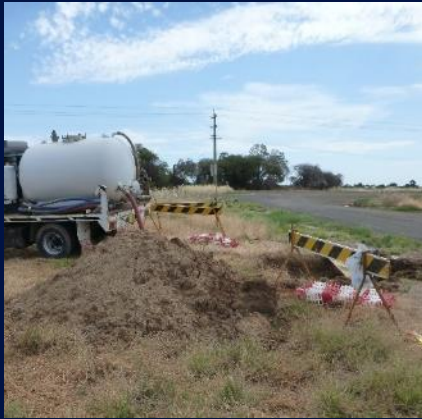
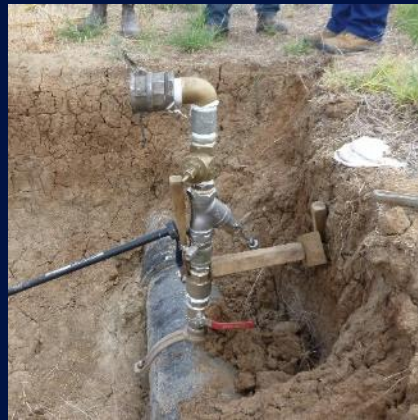
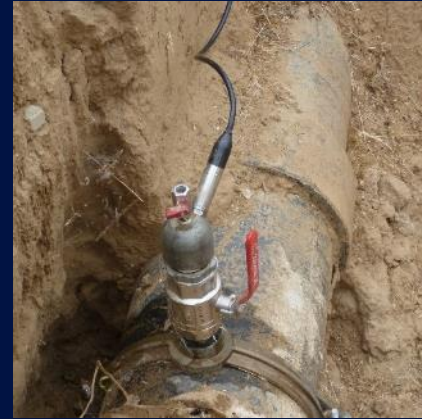
Case Study #5_Sewer Rising Main

The sewer rising main was approximately 1.2 km consisting of predominantly D.N.300 AC. The pipeline section of interest lies between a pump station and an inlet of a sewerage treatment plant.

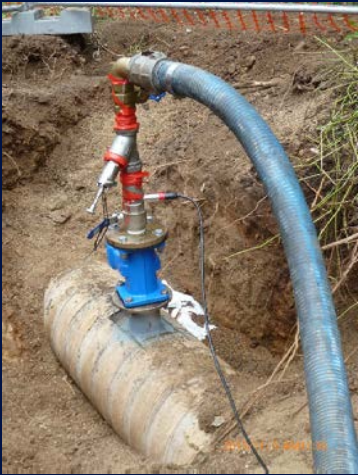
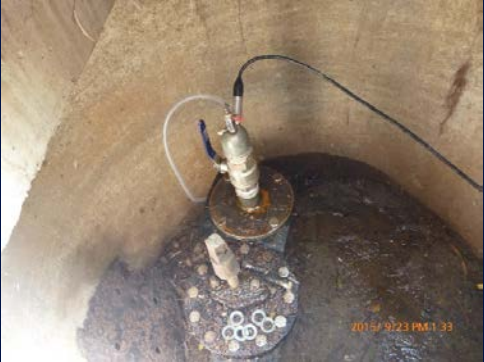
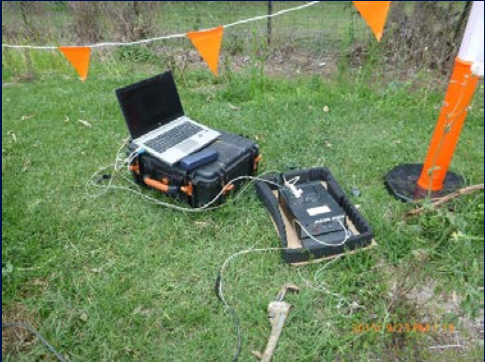
Case Study #6_ Sewer Rising Main

Location	Approx. Length (km)	Size (mm)	Material	Year
Pump station on Fortrose street to SCV2 located near the southern corner between number 18 and 20 Rowena st.	1.25	410 mm (as-built maps)	MS/MSCL	1976 from GIS
