# Performance of new stormwater system at Fonterra Tirau

*M. PEACEY, J. BARLOW (FONTERRA)*

*C. MOORE (BECA)*

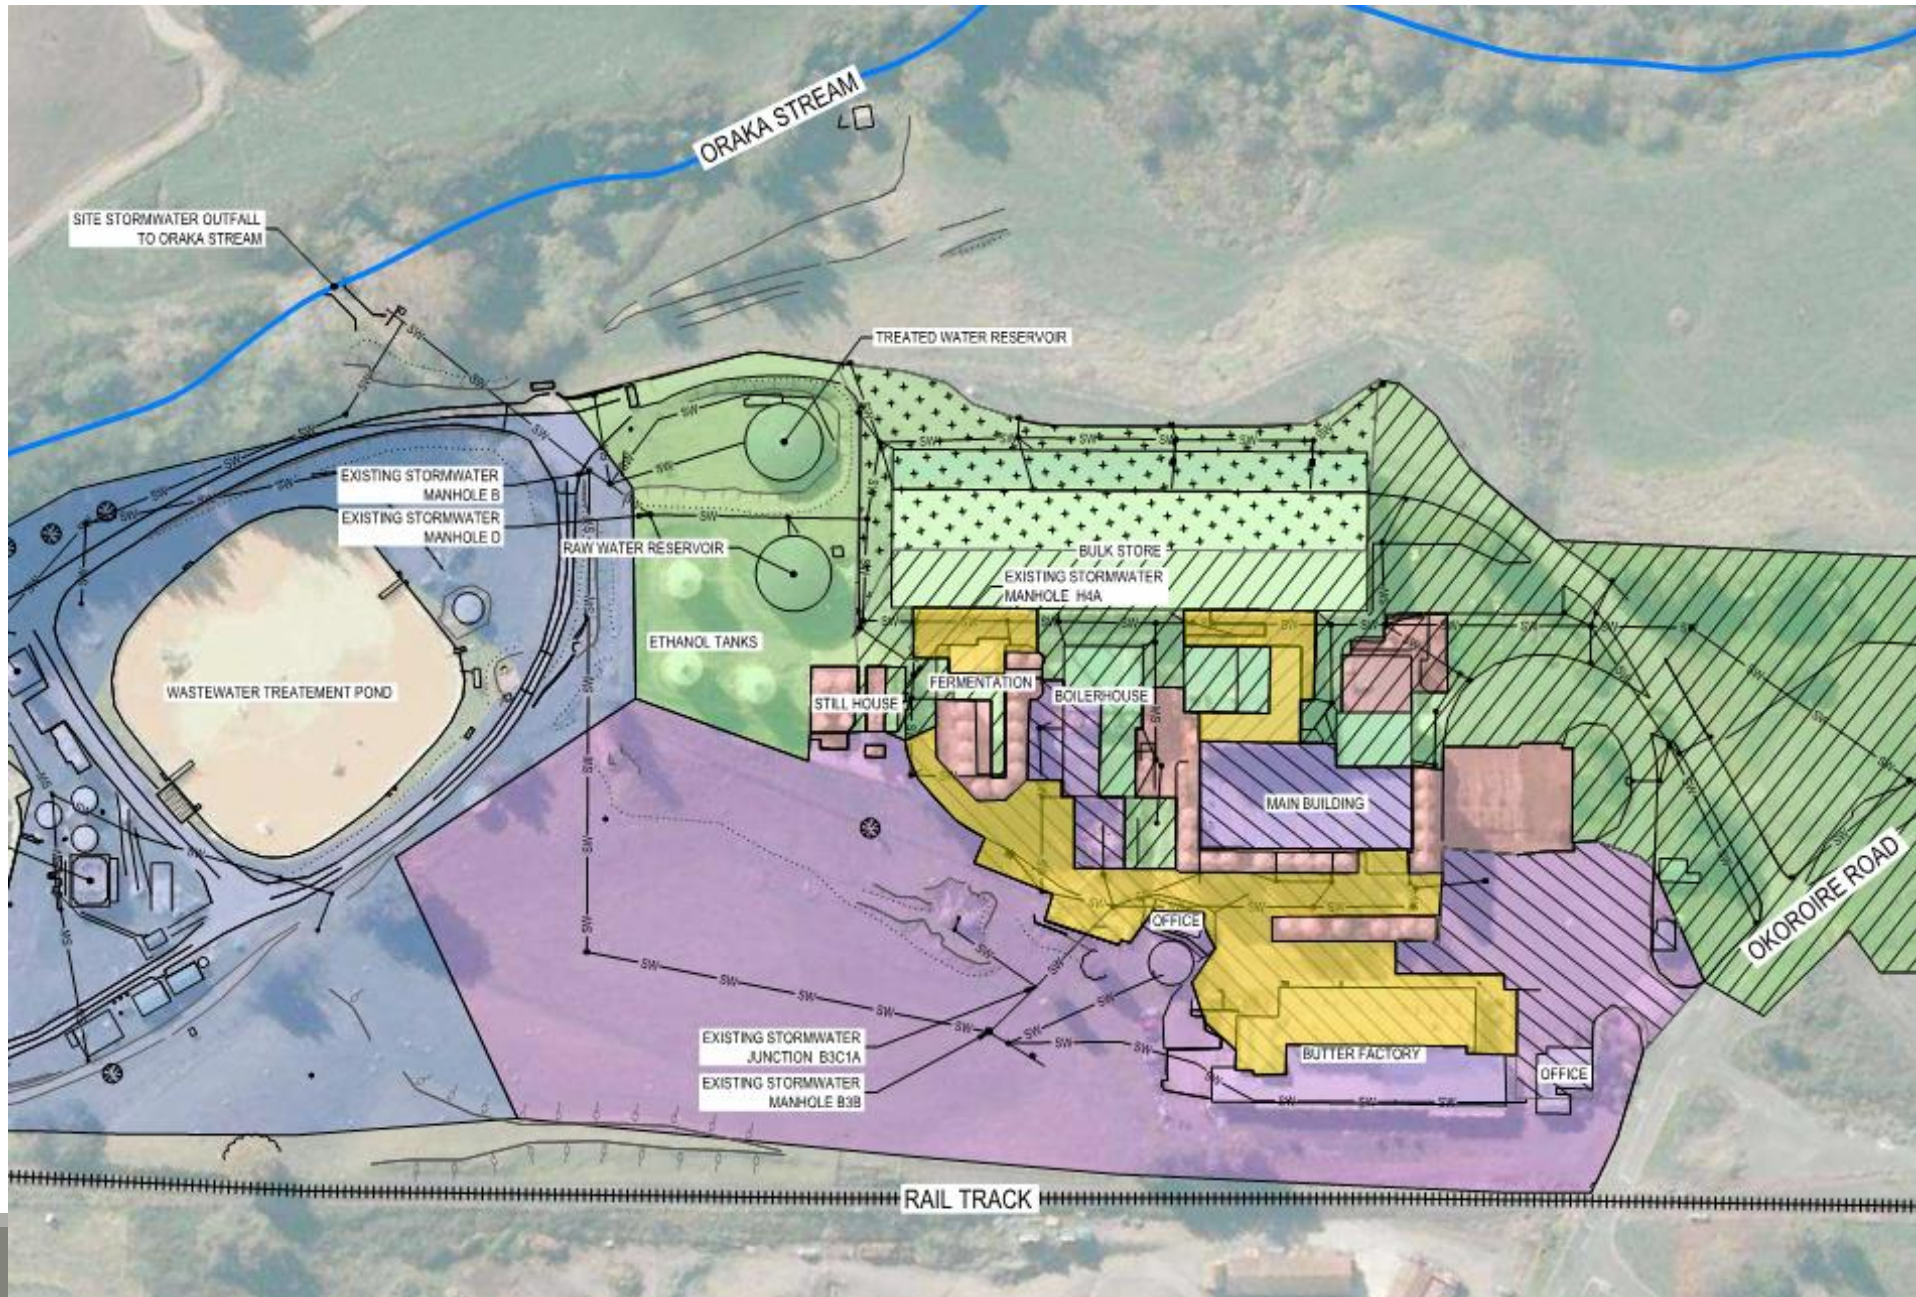
# Stormwater Risk Management

An aerial photograph of a large industrial facility, likely a wastewater treatment plant, situated in a rural area with green fields and a small town in the background. The facility features several large white buildings with blue accents, numerous cylindrical tanks, and a large parking lot filled with cars. Eight white rectangular callout boxes with black text are overlaid on the image, each containing a numbered strategy for stormwater risk management. The background shows rolling hills under a blue sky with light clouds.

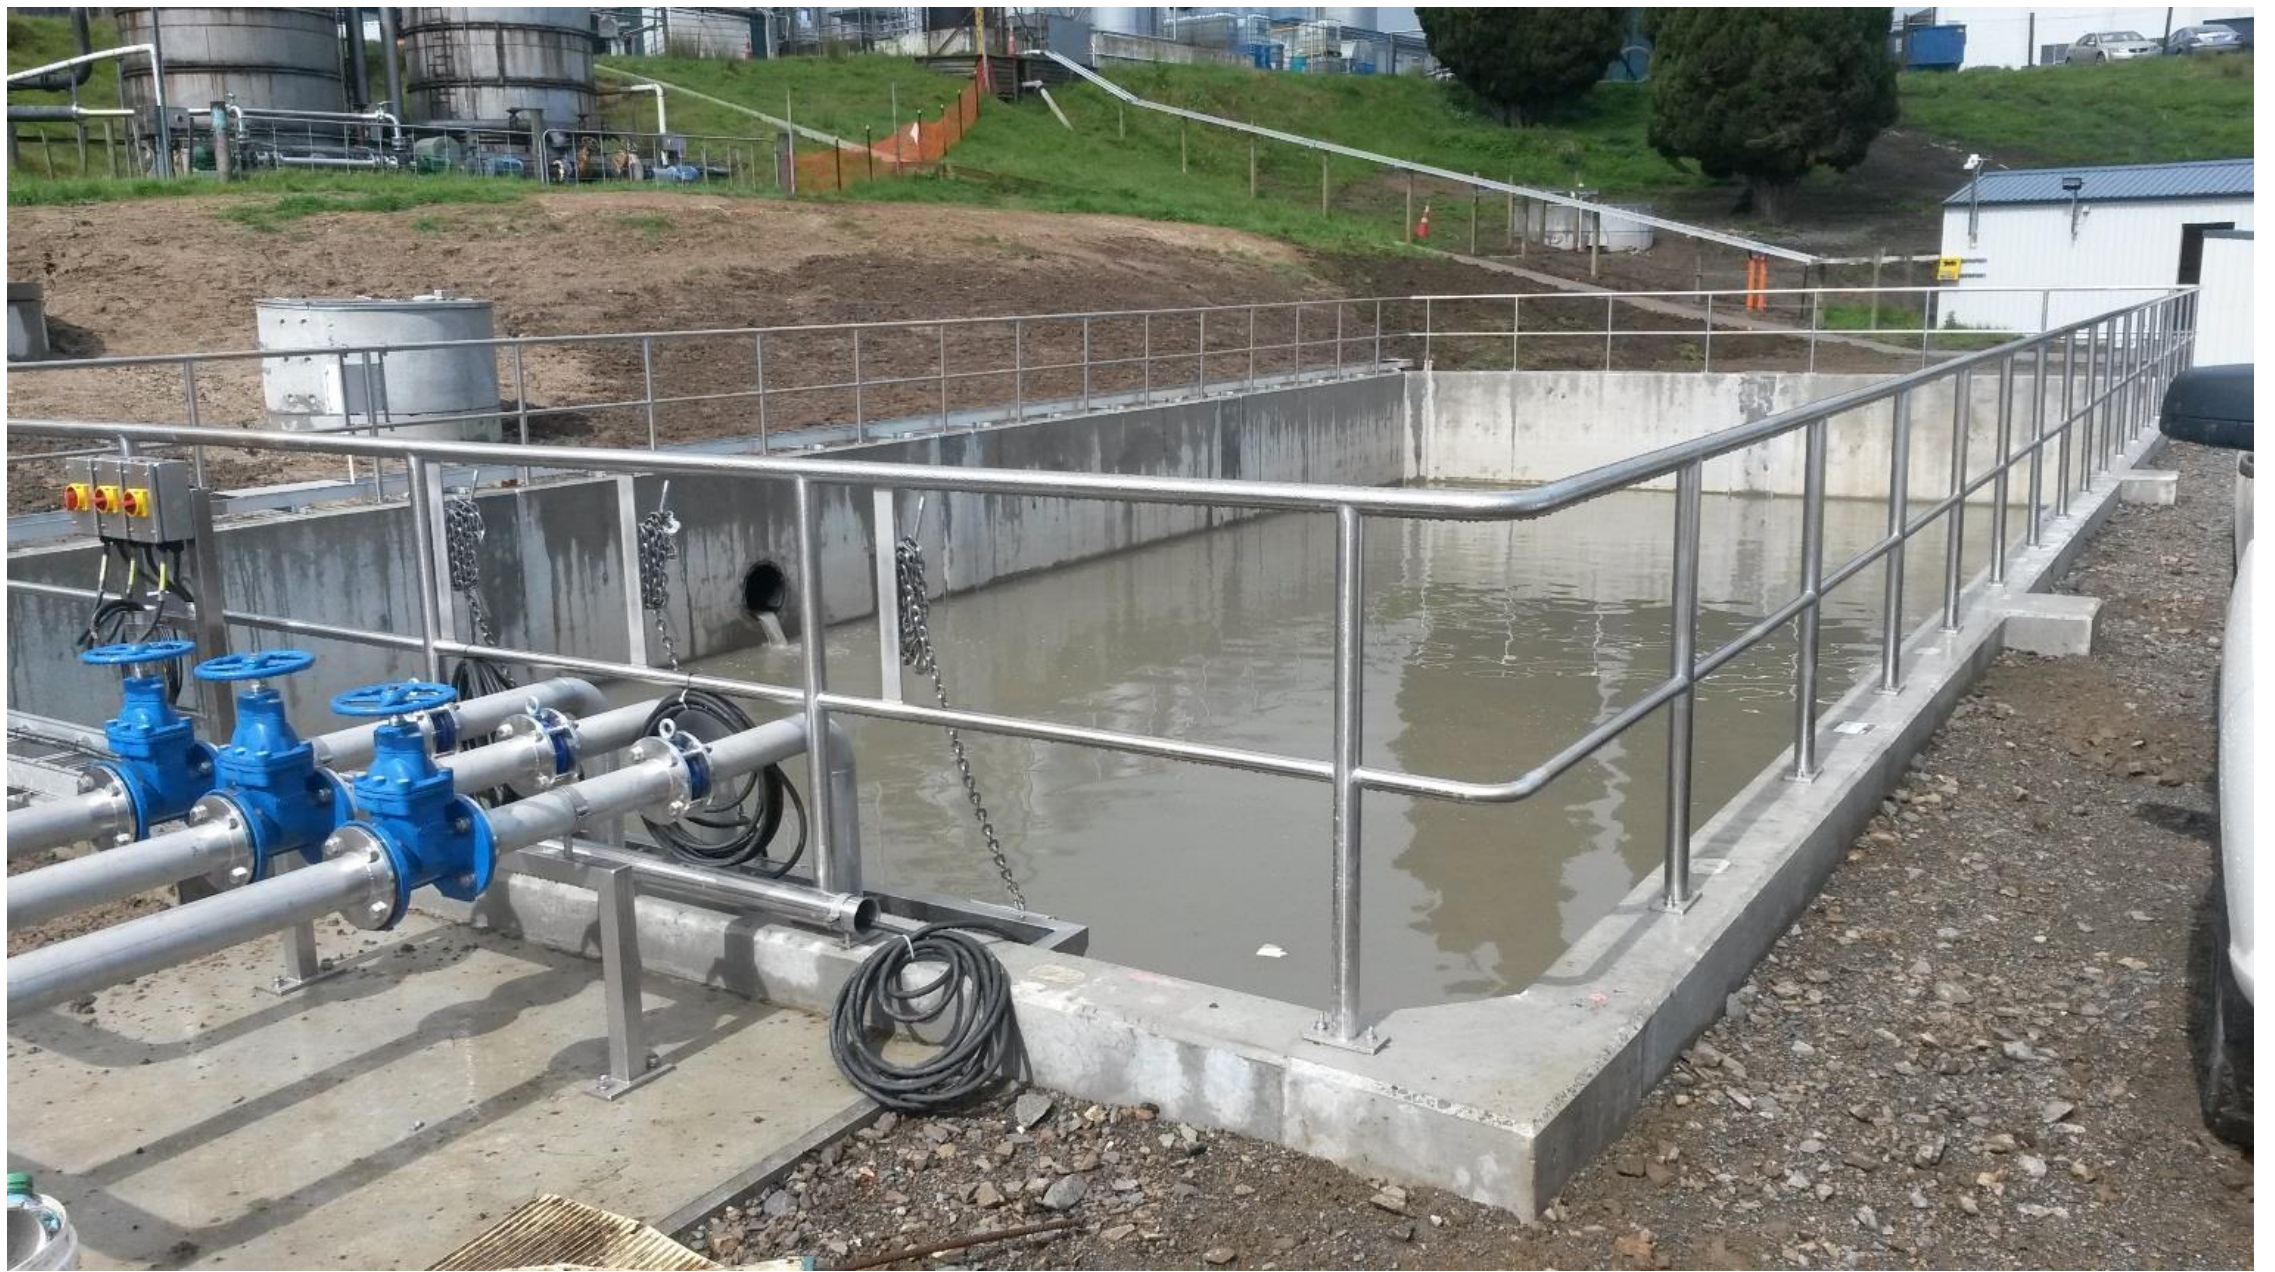
# First Flush Tank

- High strength (soluble) collection & management
- Centralised spill management
- 10mm first flush
  - 350m<sup>3</sup> total; 305m<sup>3</sup> live and 45m<sup>3</sup> dead storage
- Pumping
  - Wastewater treatment plant
  - Manual pumping to swale

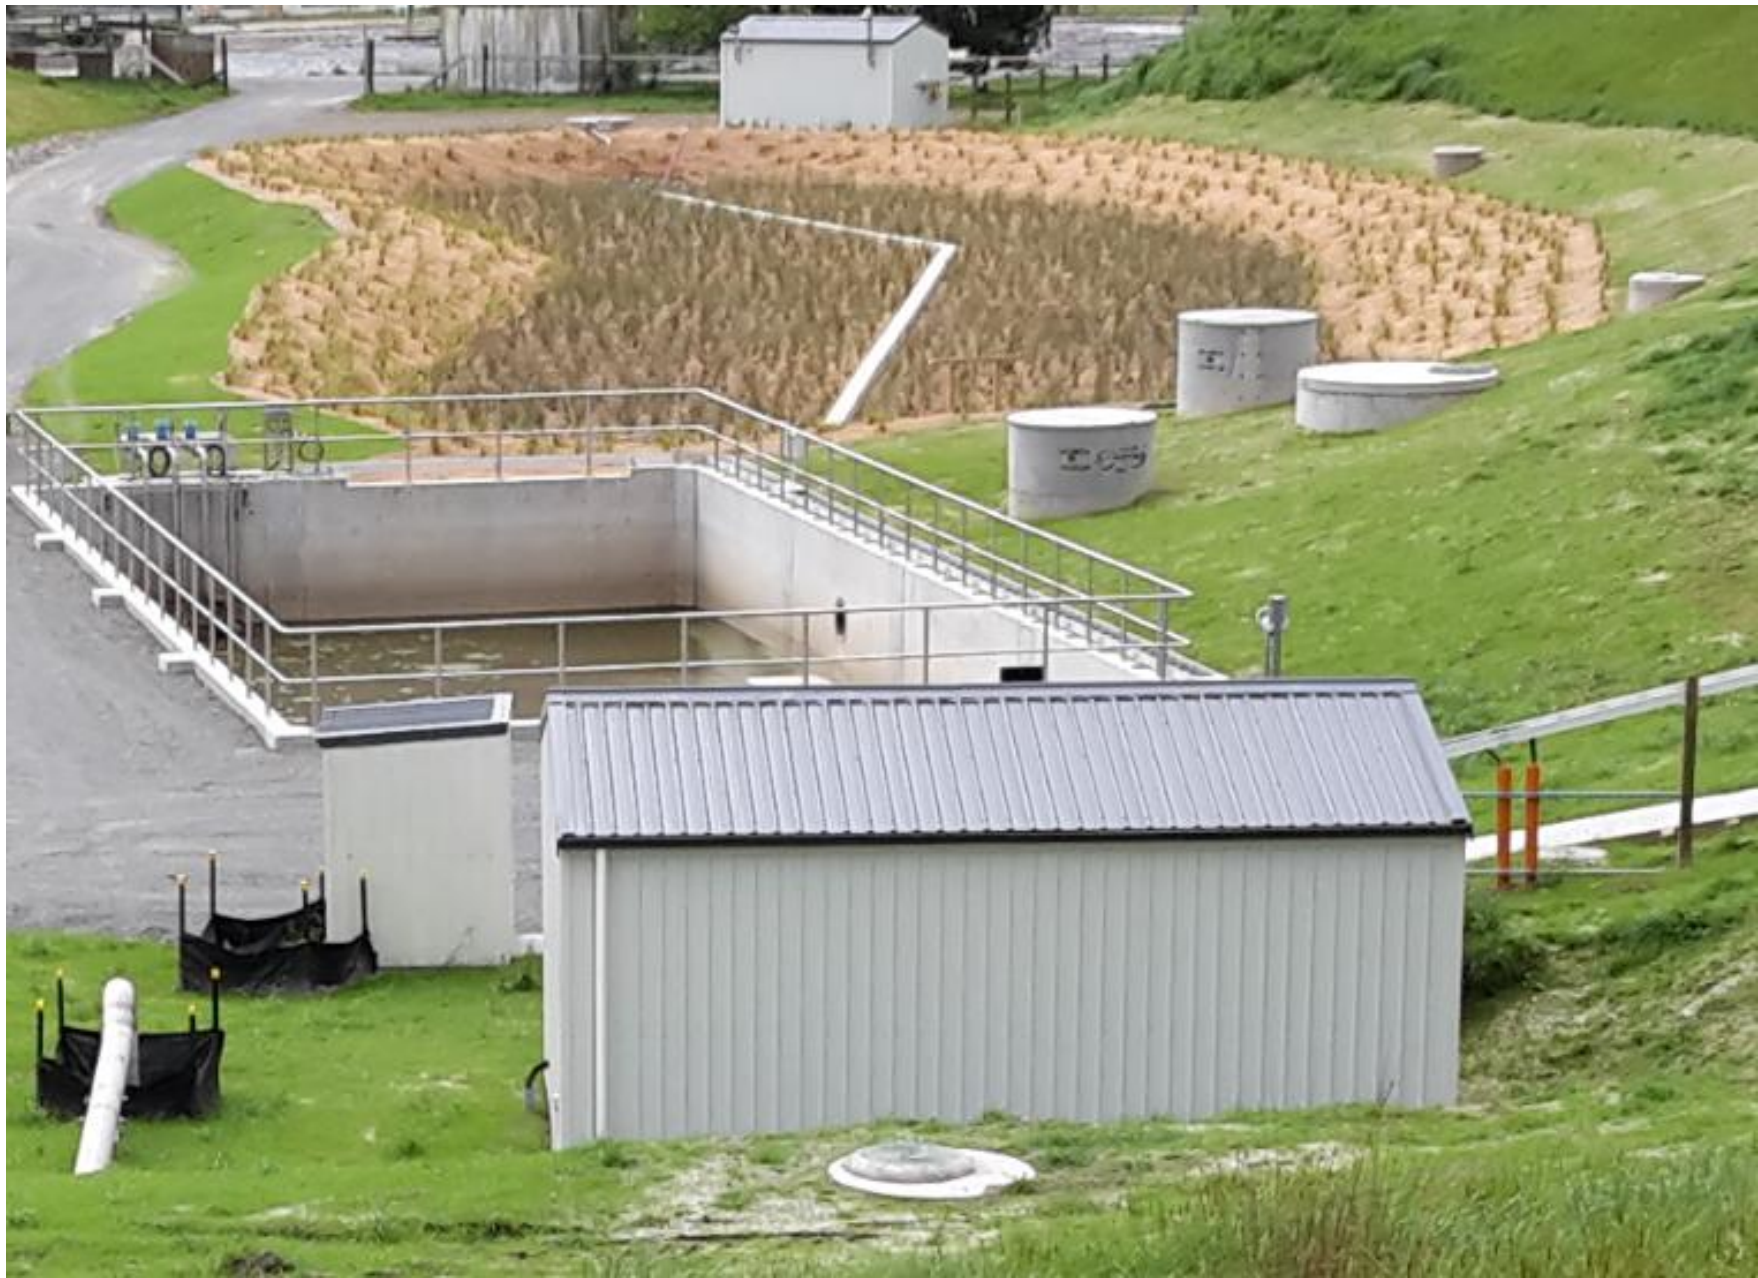
# Swale Treatment

- Suspended solids treatment
- Two 65m long, 7m wide wetland swales
- Planted in native oioi
- Bunded for calamity spill containment
- Liner provided underneath

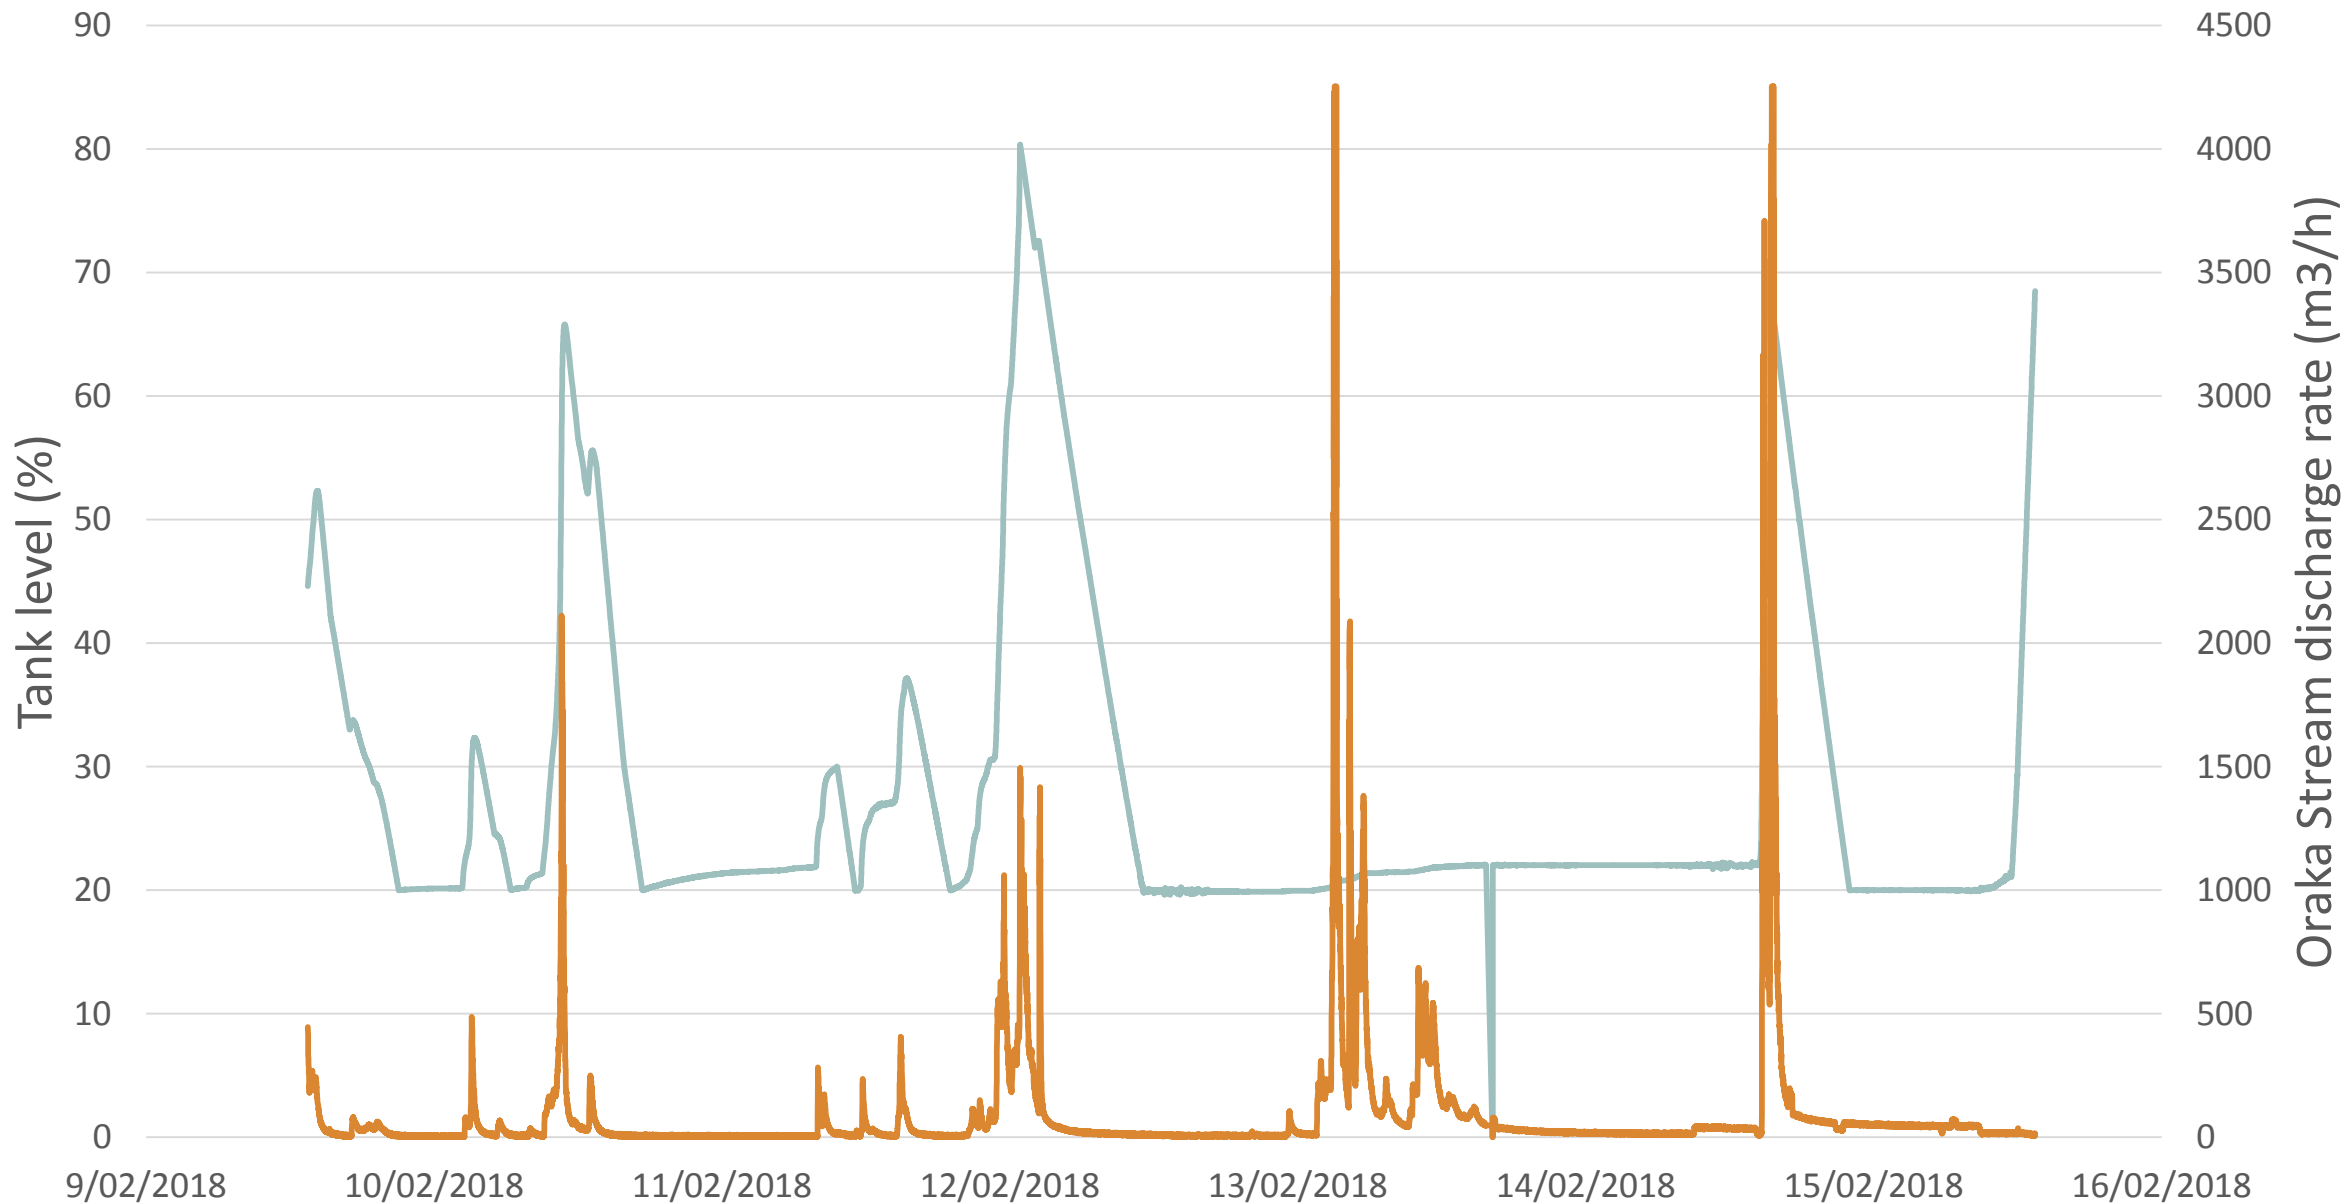
— First Flush Tank Level — Final discharge flow

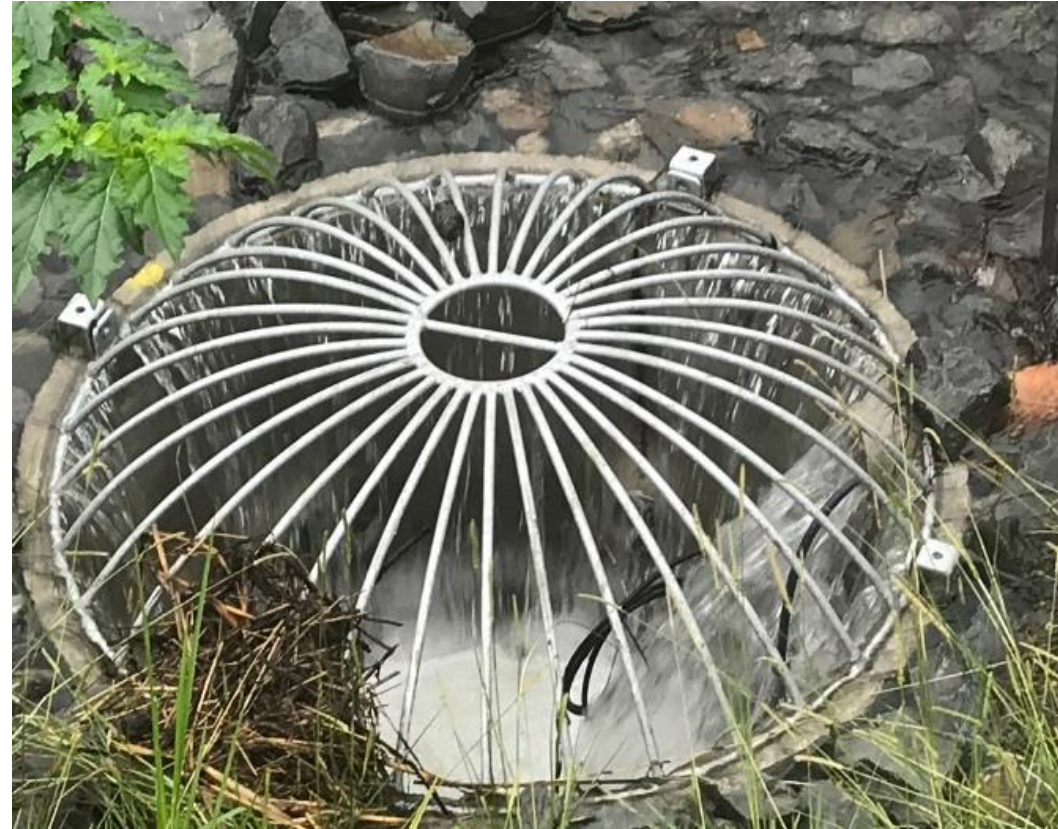
# Swale Treatment

Contaminant	Swale inlet	Swale outlet
Total suspended solids ( $\text{gm}^{-3}$ )	12	< 3
Total nitrogen ( $\text{gm}^{-3}$ )	0.42	1.12
Total phosphorus ( $\text{gm}^{-3}$ )	0.08	0.086
COD ( $\text{g O}_2 \text{m}^{-3}$ )	12	12
