# PUBLIC SAFETY AT CATCHPITS – LESSONS FROM TRAGEDY

**J. Reddish (WSP Opus), C. Mountjoy (Auckland Council), D. Blackburn-Huettner (Auckland Council)**

## ABSTRACT

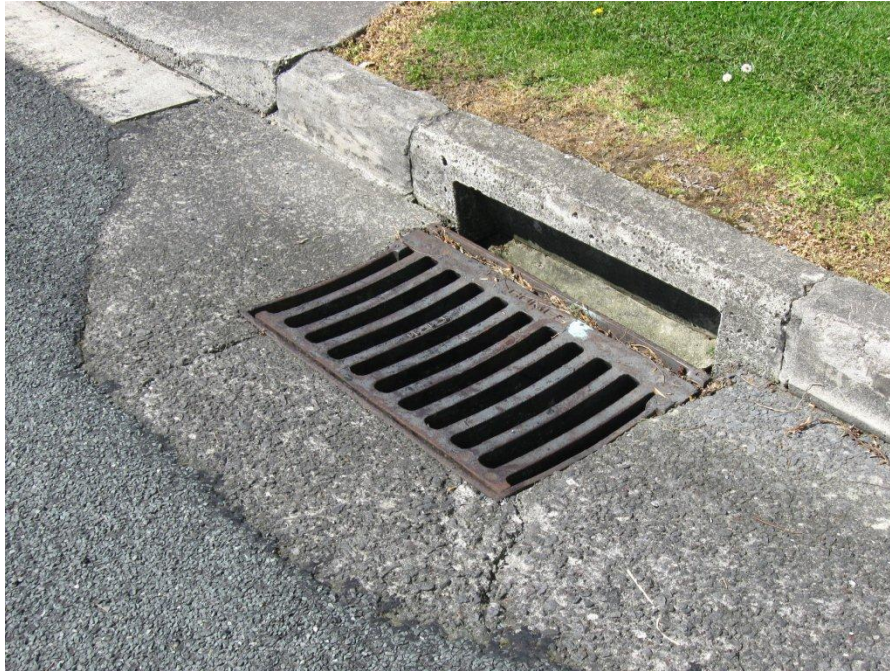
*Figure 1: Typical Auckland road catchpit*

A typical road catchpit is shown in Figure 1. This catchpit has been in use in Auckland for over half a century. Over the last 10-15 years a larger variety of catchpit types have developed in response to a need for improved hydraulic performance and due to changing road use e.g. cycle friendly grates. Auckland Council and Auckland Transport currently specify five different types of catchpits as suitable for public infrastructure.

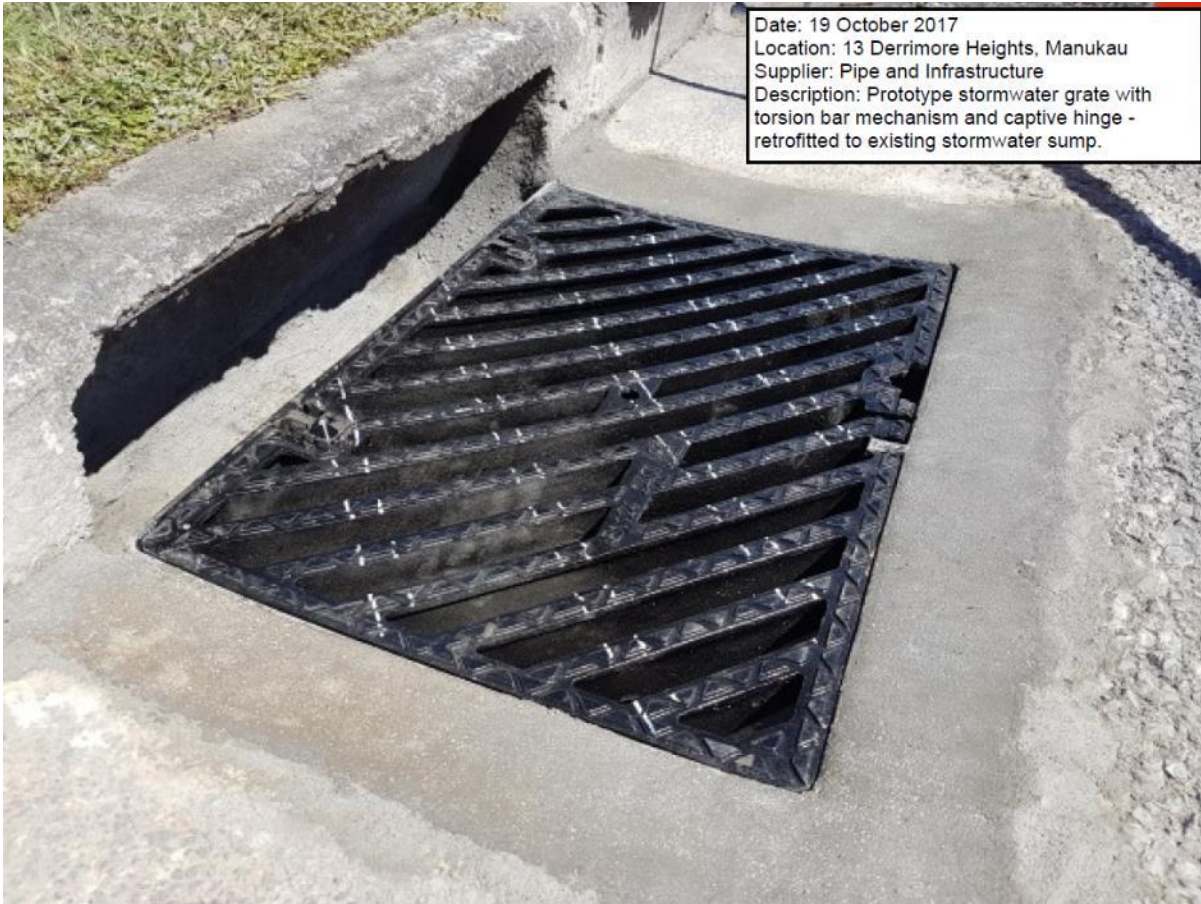
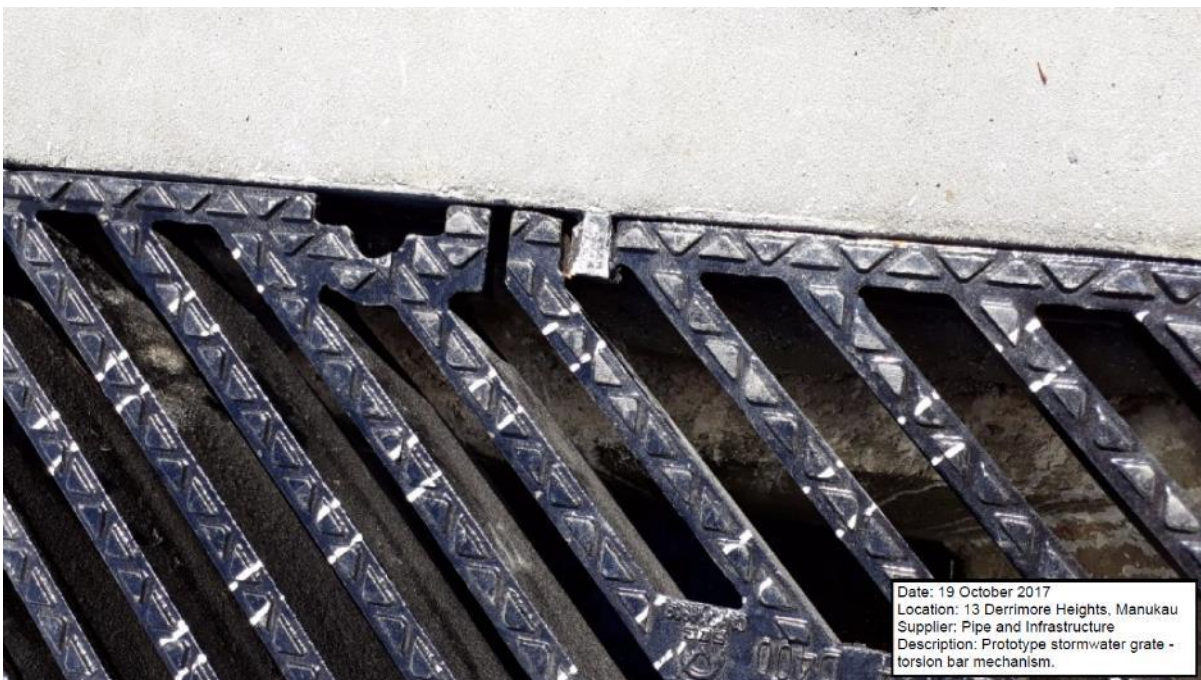
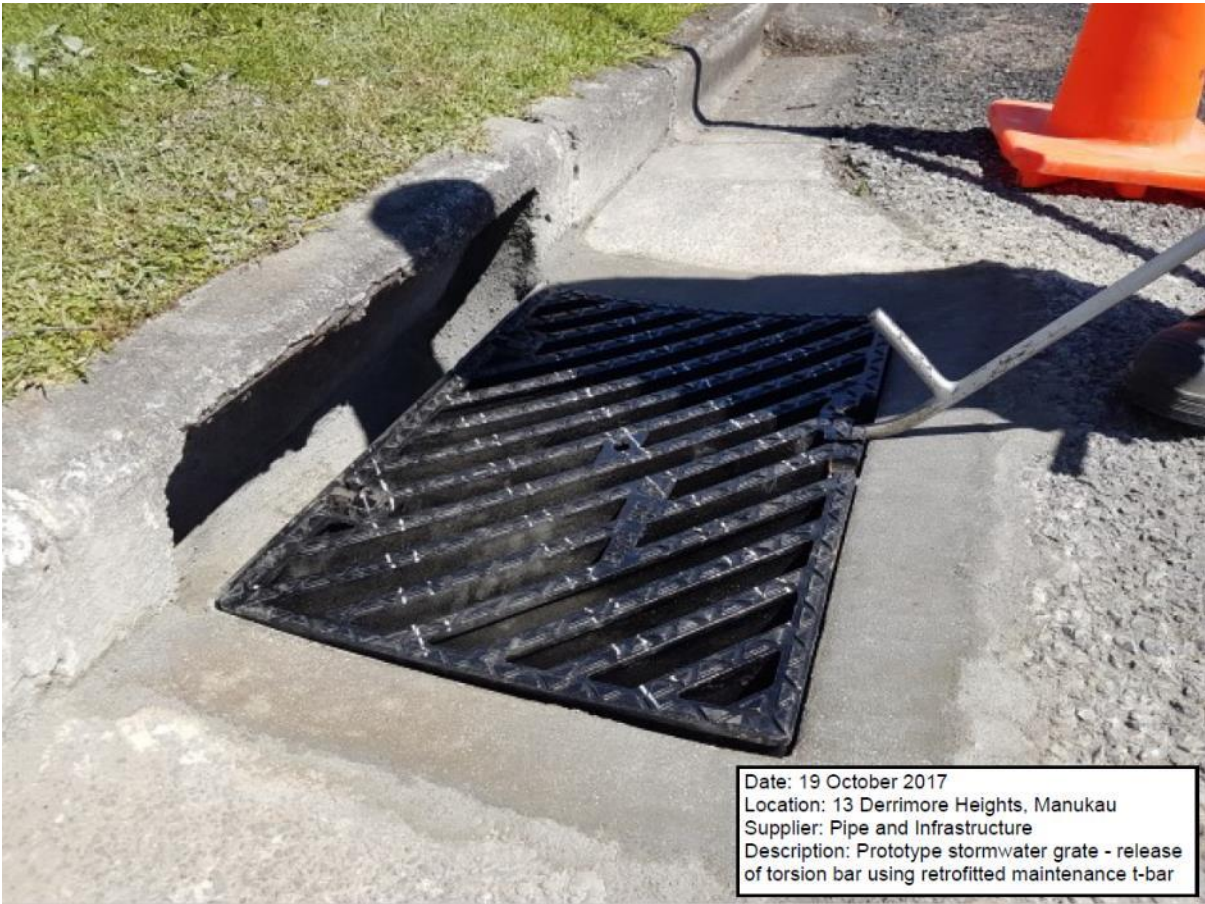
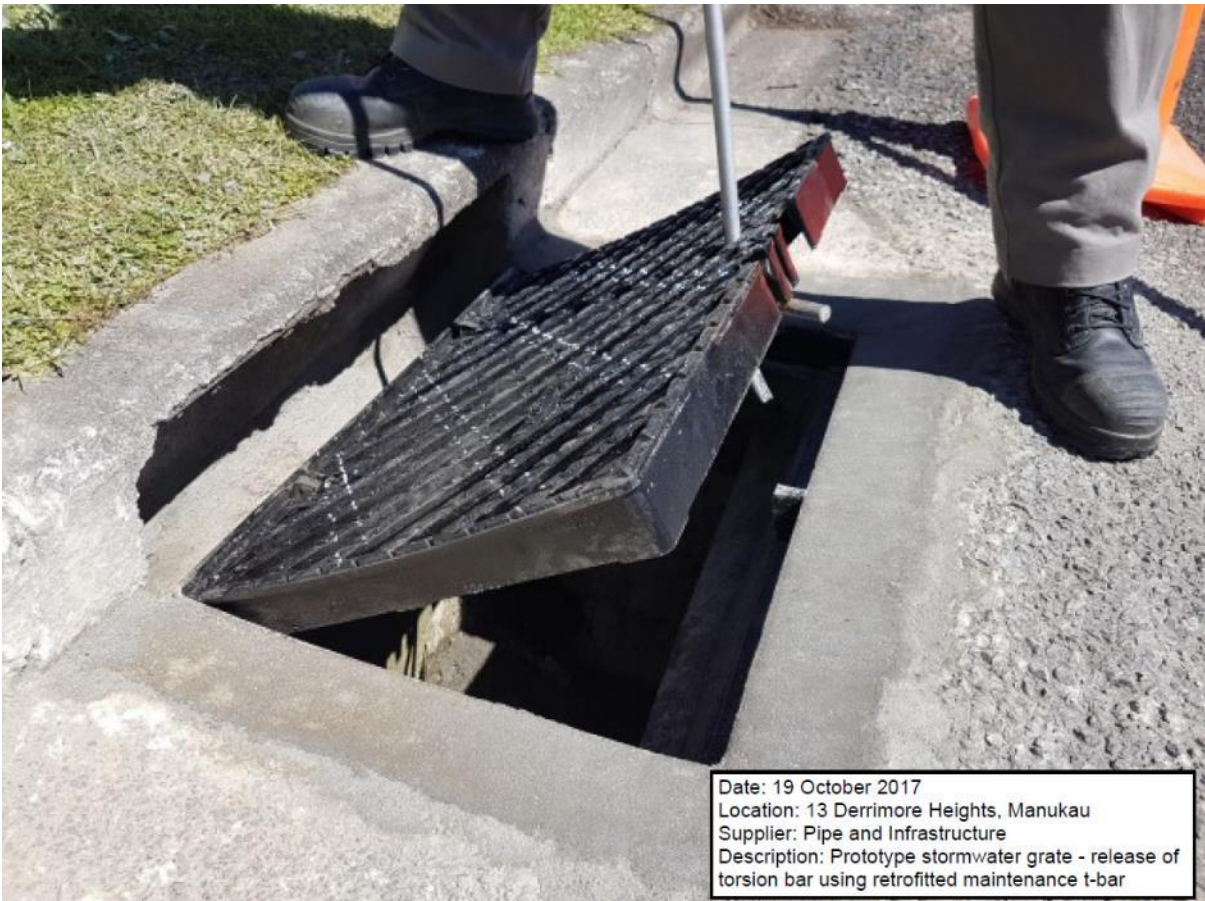
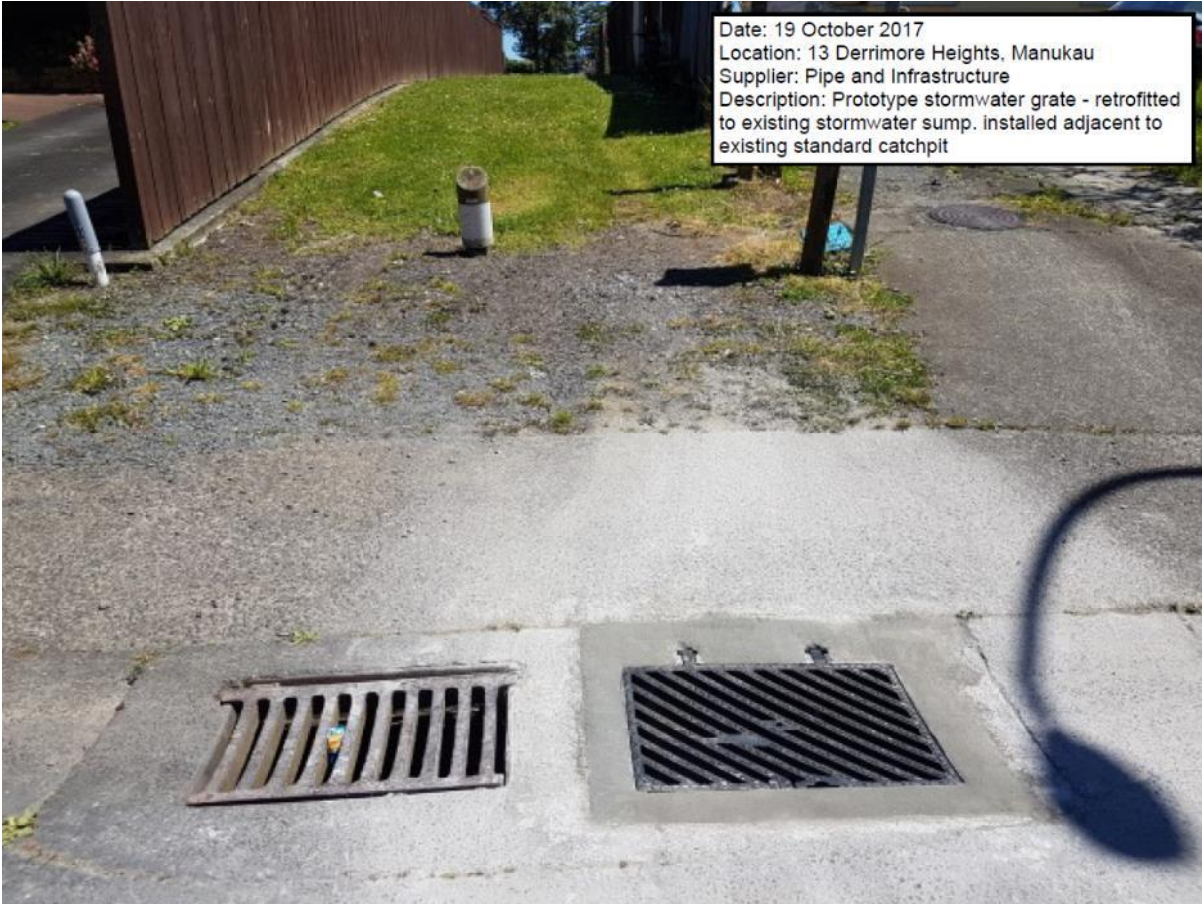
## APPENDIX B – EXAMPLE LOCKABLE CATCHPIT GRATE PHOTOS

Date: 19 October 2017  
Location: 13 Derrimore Heights, Manukau  
Supplier: Pipe and Infrastructure  
Description: Prototype stormwater grate - retrofitted to existing stormwater sump. installed adjacent to existing standard catchpit

Make catchpits only openable with special tool (like manholes)	<p>This control may be suitable for retrofit on a case by case basis. An assessment would be required to demonstrate that the benefits offered outweigh the constraints and potential increased risks to other hazards.</p> <p>Implementation of control in new catchpit design may offer convenient method of reducing safety risk associated with unauthorised access to catchpit without significant impact of increased risk to new or other hazards.</p>	Yes
Include an insert to capture items dropped down a catchpit	<p>As this intervention does not isolate people from the catchpit, is not designed to provide a health and safety function (unlike a grate) and may encourage access, it is not recommended as a specific health and safety measure.</p> <p>Nonetheless, where a gross pollutant trap (e.g. LittaTrap or similar) can be justified on environmental risk, it is likely to have a health and safety benefit for the public.</p> <p>Other catchpit inserts (e.g. Enviropod or TetraTrap) would not provide the same Health and Safety benefit as they do not isolate gross pollutant (or personal items) within arm's reach.</p>	No
