DIAL 111 – TAKAKA FIRE FIGHTING SCHEME

David Light, MWH NZ Ltd

The township of Takaka, in the Tasman district previously had no reticulated water supply. Water for fire fighting was drawn from numerous wells around the central business district (CBD), but these were not reliable and deemed inadequate.

A working party was set up and the final recommendation was to install a fire fighting reticulation network around the CBD only. The completed design now allows local and immediate access to water supplies required by the fire service.

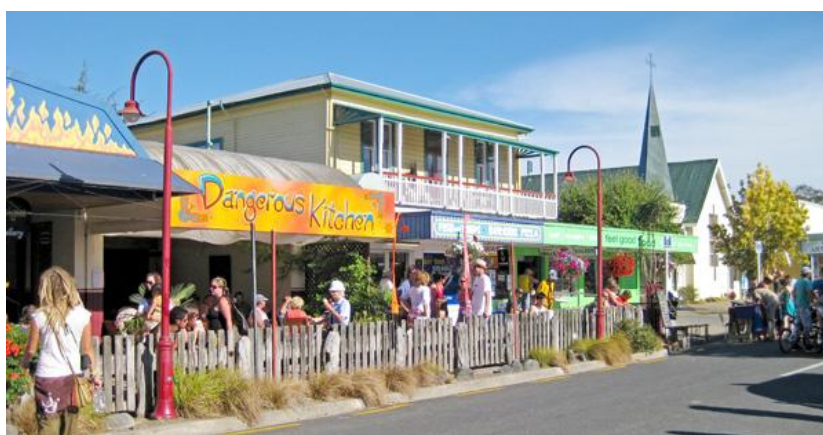
In the Takaka CBD, the risk of fire spread is high due to the close proximity of old style wooden buildings. In a significant building fire, the NZFS would need several water sources available to adequately control the spread of the fire to neighbouring buildings, including buildings behind and across the street. The distribution and effectiveness of the fire wells made controlling any sizable fire very difficult.

Photograph 1: Wooden buildings within the Takaka CBD

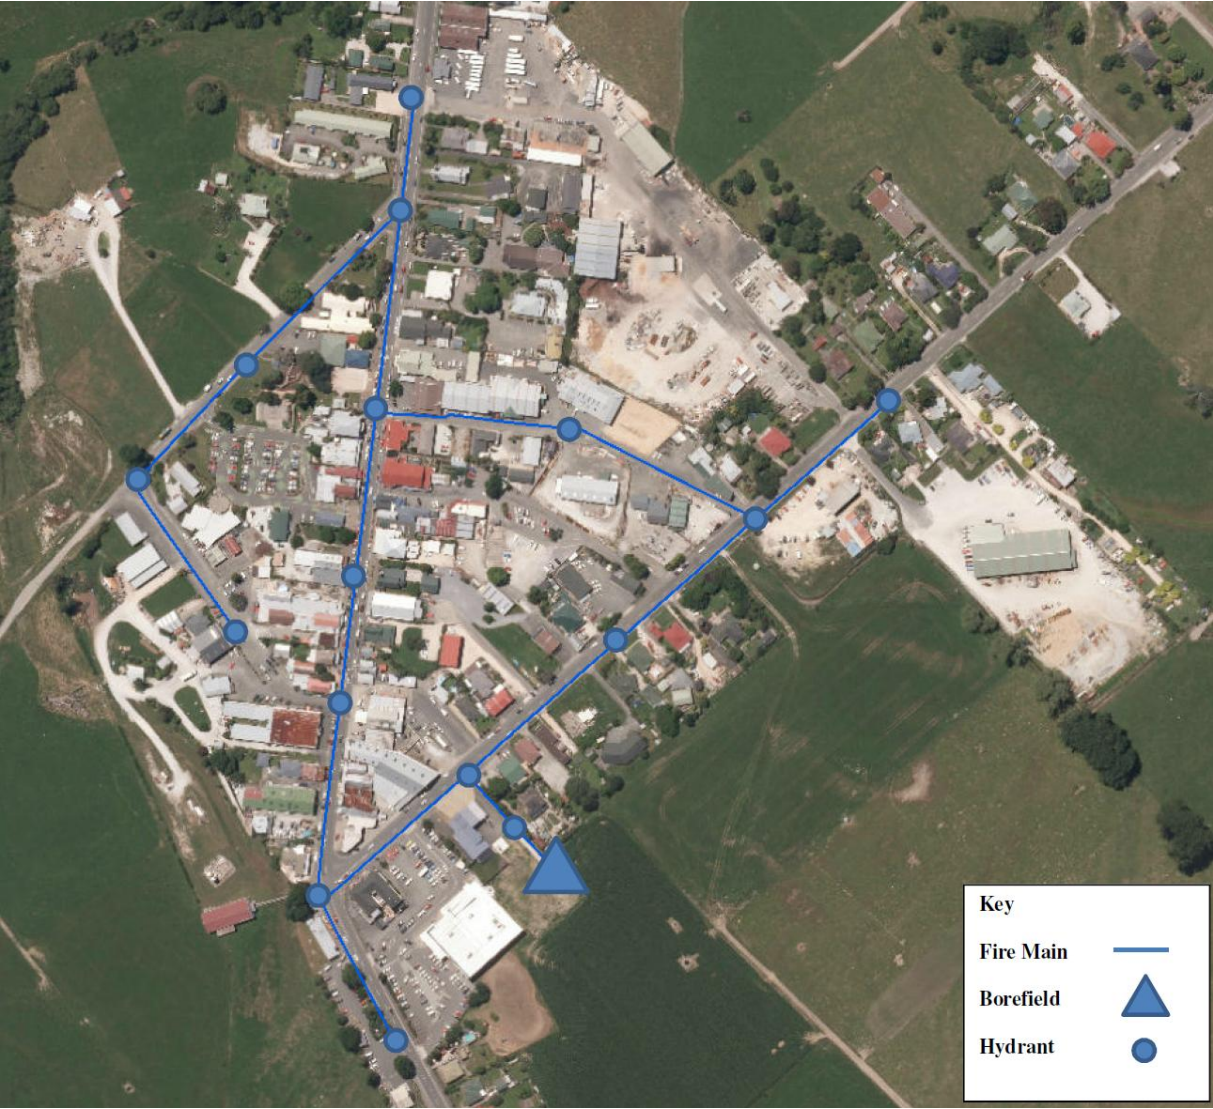
A layout of the new fire fighting water supply scheme within the Takaka CBD is shown in Figure 3.

Figure 3: Layout of the new scheme

The fire main in the CBD network is approximately 1,740m long. The hydraulic analysis found that for the required design flow and pressure, a combination of 1170m of 150mm NB and 570m of 200mm NB was required.

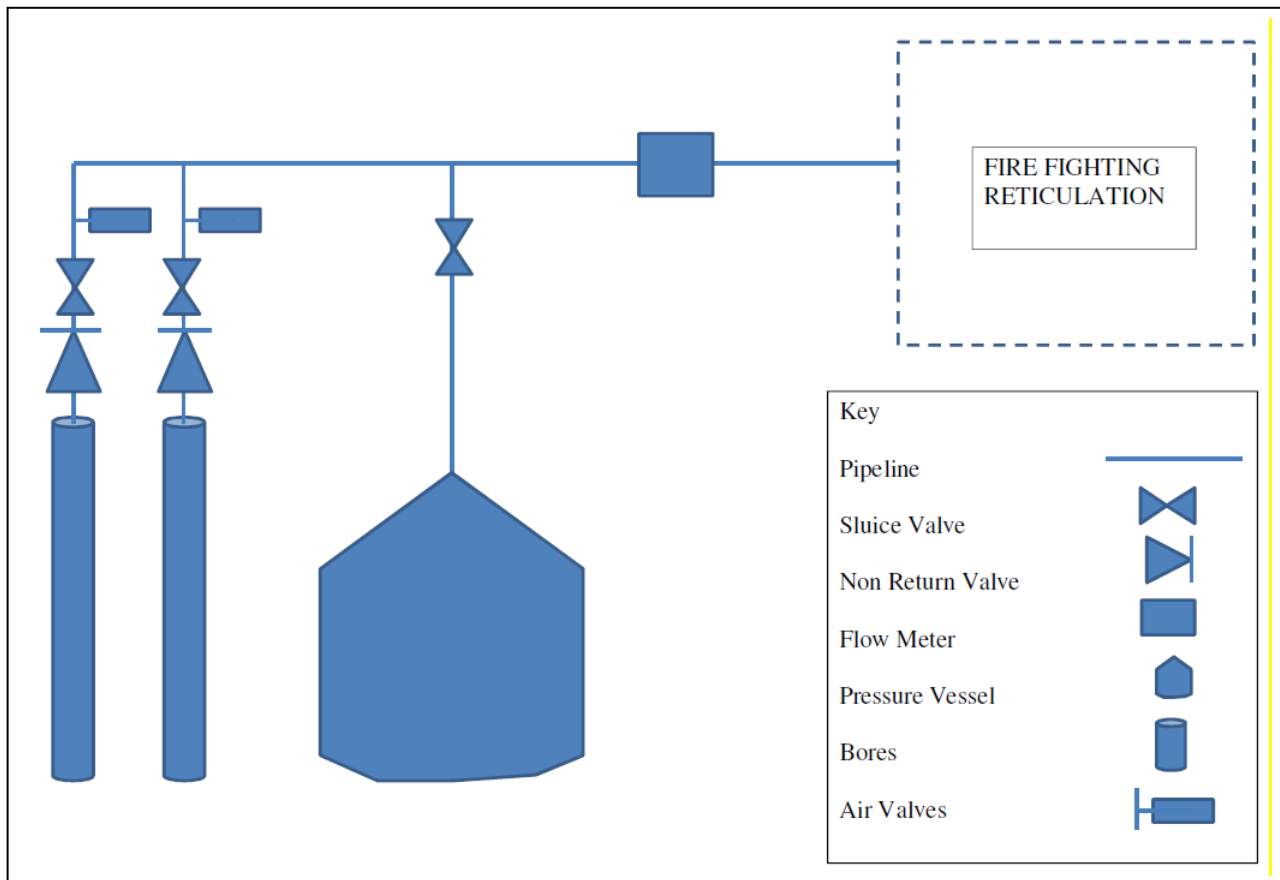
A schematic of the new fire fighting water supply scheme within the Takaka CBD is shown in Figure 4.

Figure 4: Headworks schematic

The pressure vessel was originally proposed to be used to compensate for the unavoidable losses (leakage) from the system and provide instantaneous flow to the hydrants, while the pumps ramped up. After the hydraulic analysis was performed, the optimum size for the pressure vessel was determined as being 4,000l. This would also eliminate negative pressure from surge effects of the pipeline.

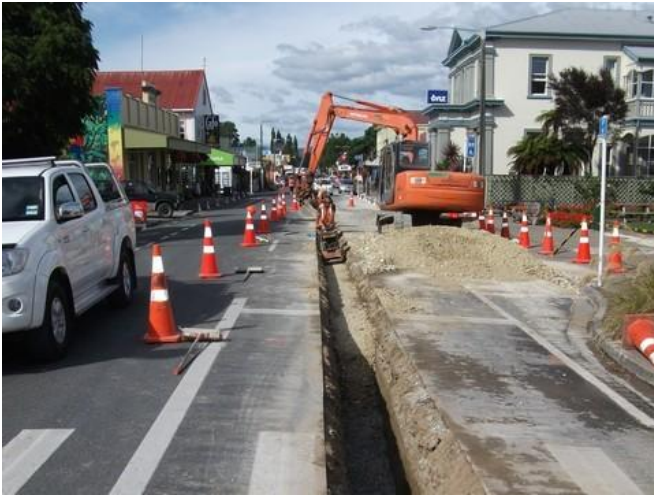
Photograph 4: Construction of fire main on SH60

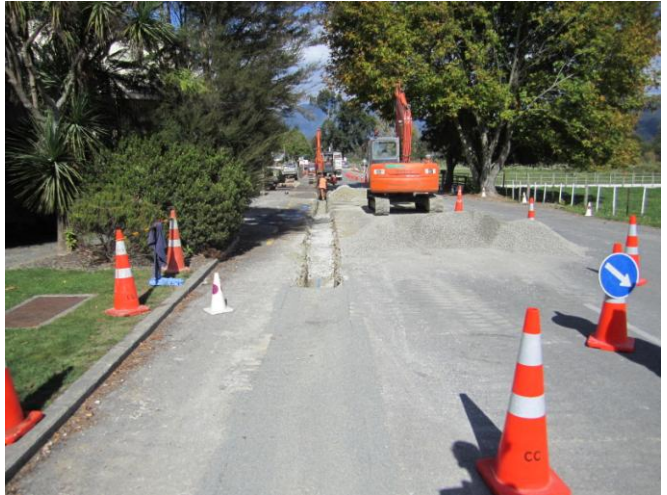
Photograph 5: Construction of fire main on Reilly Street

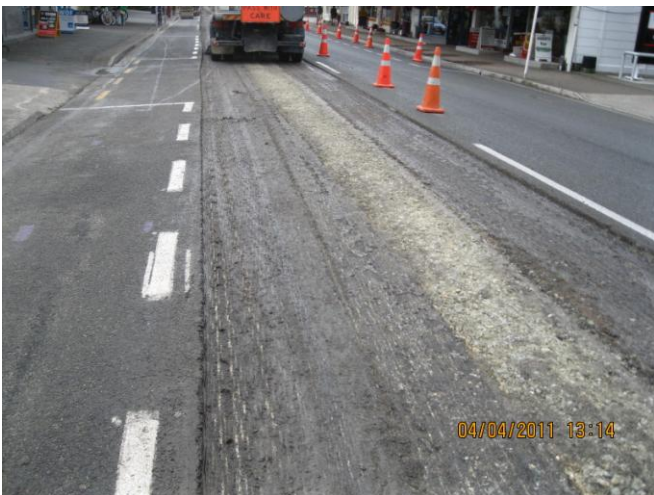
The reinstatement of the trench line within state highway included a full lane width reinstatement of 40mm depth of Hotmix 16. Prior to resealing the road, the entire lane and parking was closed off so the existing surface could be milled (as shown in Photograph 6).

Photograph 6: Milling along SH60

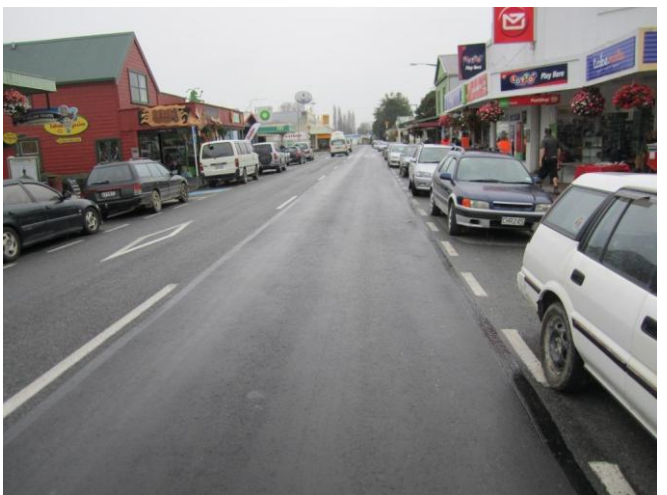
Photograph 7: Final reinstatement along SH60

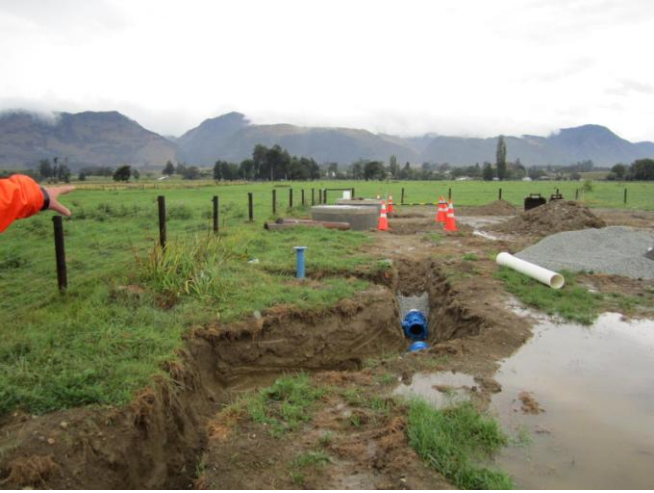
Construction of the new bores, headworks and control equipment were located within a grassed area behind the fire station. One of the main design changes during construction was the increase of the plinth height that supported the generator. Following detail design, a flood analysis showed this plinth would need to be raised from 550mm to over 1m above ground level to ensure the generator would remain above a 100 year flood level.

Photograph 8: Early construction of the borefield

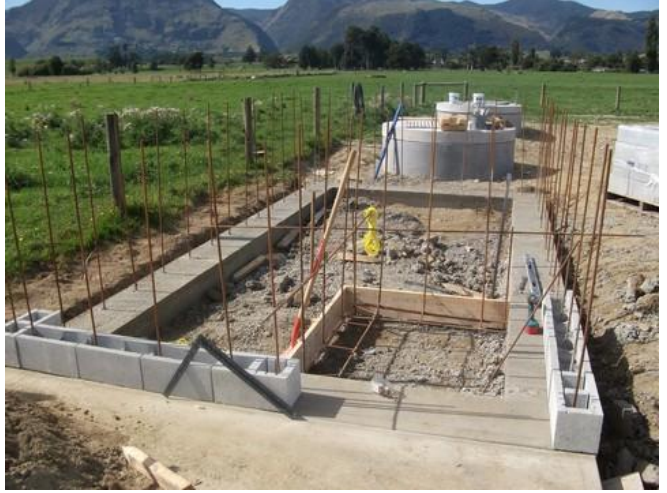
Photograph 9: Plinth for the generator

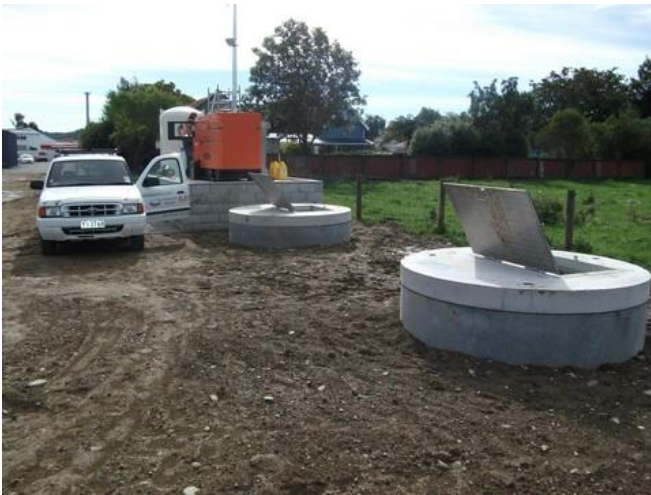
Photograph 10: Bores and generator nearing completion

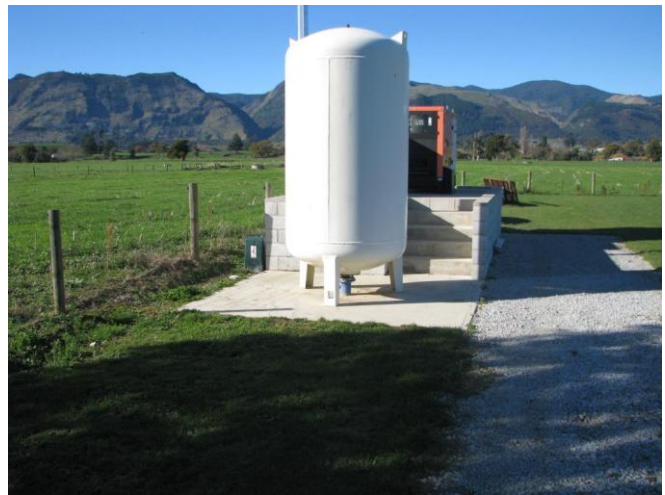
Photograph 11: Installation of the pressure vessel following completion

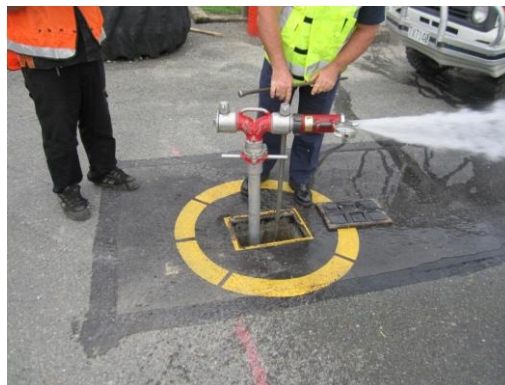
The commissioning of the pipeline took place through two hydrants located at the end of the fire main on Junction Street. This line was the longest length of main and was a dead leg. The NZFS assisted in the flow test, where both the flow rate and pressure were recorded from two hydrants to confirm the system was achieving FW3 requirements.

Photograph 12: Flow test assisted by the NZFS
