SMART SOLUTIONS FOR UNDERSTANDING SIMPLE SYSTEMS -

Paul King – Opus International Consultants Ltd.

ABSTRACT

Opus International Consultants Ltd. was engaged by the Christchurch City Council to investigate their stormwater network in the Port Hills. This investigation was driven by Council to both determine the network condition and prioritise the repair of damage anticipated from the series of earthquakes in Canterbury from September 2010 – June 2011.

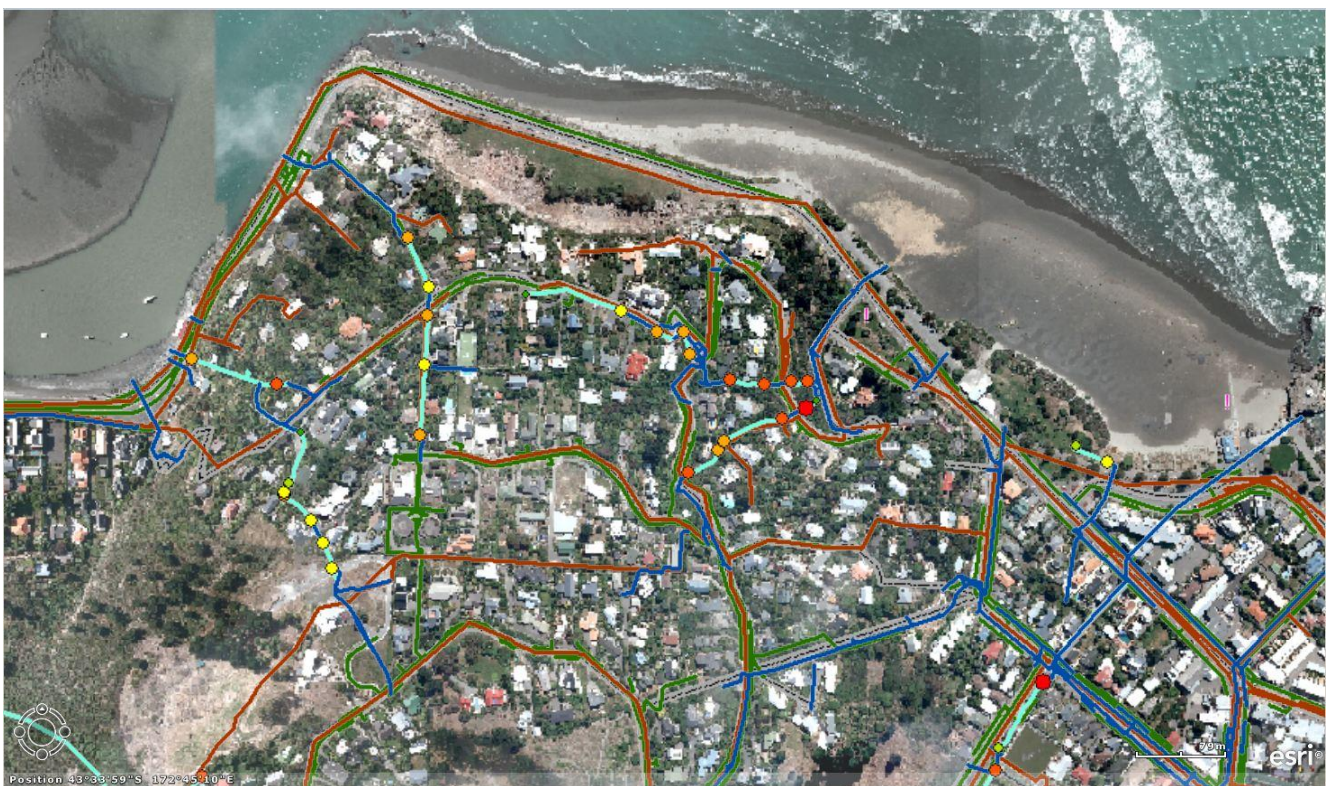
Figure 2: Example of the combined review data showing criticality score of each water course (coloured lines) and priority score colored dots. Refer to legend (below)

The prioritisation programme of Hillside stormwater assets repairs and renewals will use the following calculation:

$$\text{Asset priority} = \text{Average asset condition score (1 - 5)} \times \text{Maximum Criticality score (1 - 5)}$$

This simple equation allows all the watercourses in the eight projects areas to be ranked and allows the CCC to direct available resources to the infrastructure most likely to fail with the highest consequences of failure first.
