# CONTROL AND OPTIMISATION OF A HIGH STRENGTH NITROGEN INDUSTRIAL WASTEWATER BNR PLANT

*D.D. Irvine and A. Khan*

*Pattle Delamore Partners Limited, Auckland, New Zealand*

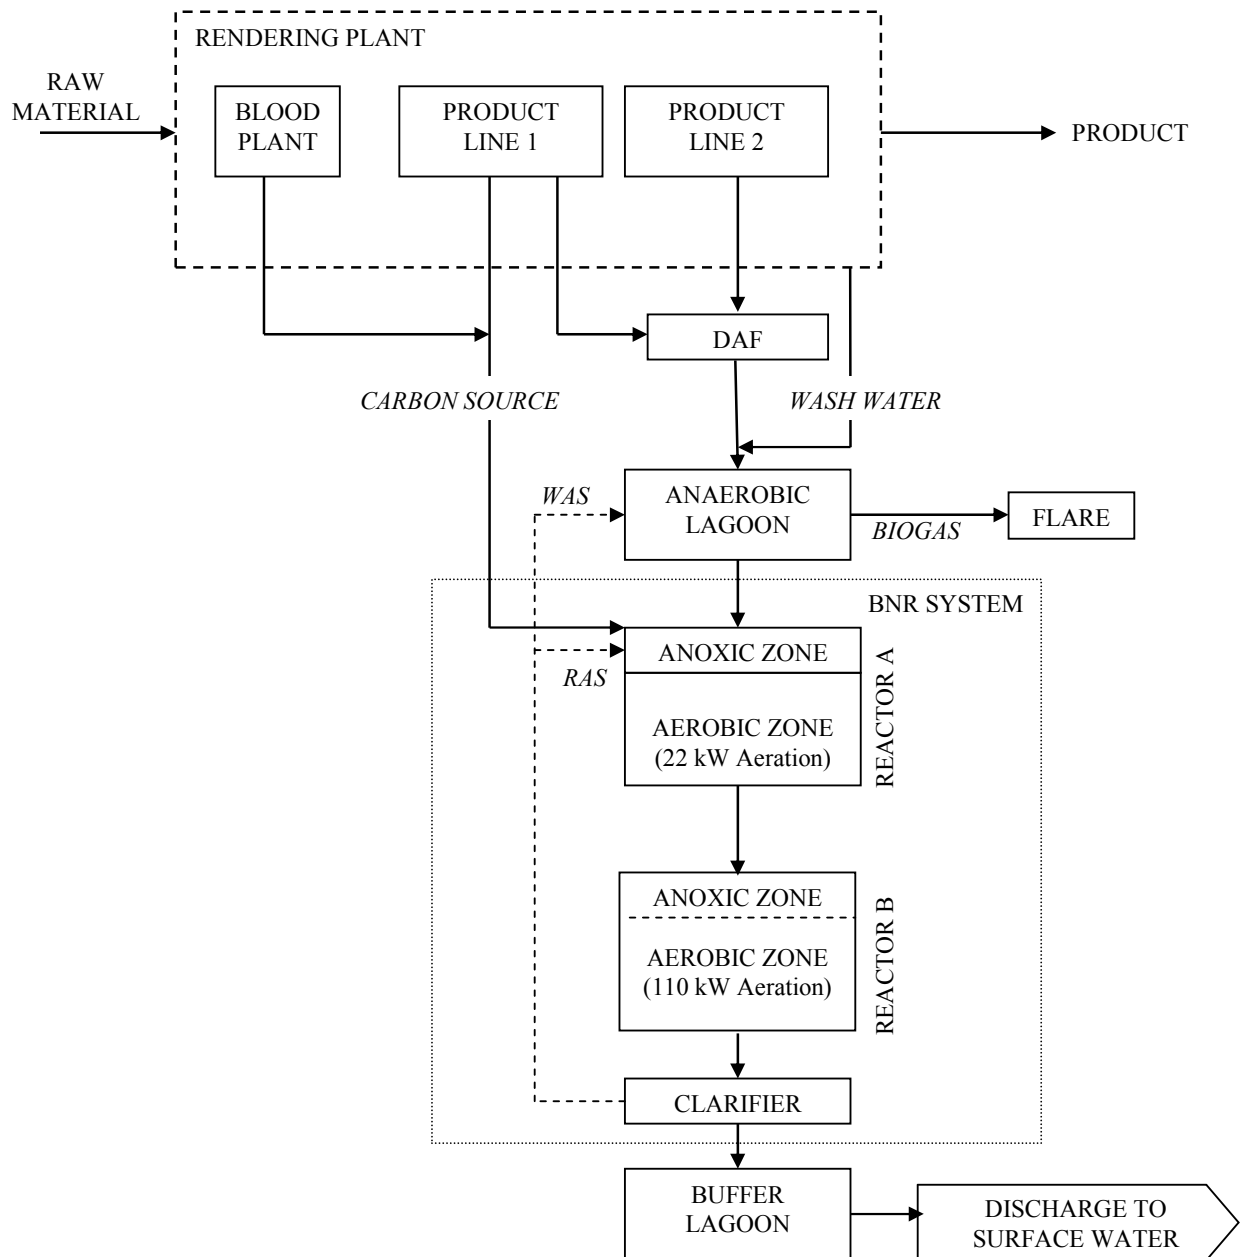
The wastewater treatment system utilised at the rendering plant is characteristic of many rendering wastewater treatment systems around New Zealand, that discharge directly into the receiving environment. The treatment system incorporates primary screening, physico-chemical treatment in a dissolved air flotation (DAF) tank, prior to biological treatment in an anaerobic lagoon and biological nitrogen removal (BNR) in an activated sludge treatment system. The BNR plant at this site consists of two activated sludge reactors in series with anoxic selectors at the beginning of each reactor. Figure 1 details the wastewater treatment system prior to the process deterioration.

Figure 1: Wastewater Treatment System prior to BNR Process Deterioration

The BNR system configuration, prior to the process train upgrade, had the anaerobically treated effluent entering a small tank reactor (400 m<sup>3</sup>) with an initial anoxic zone followed by an aerobic zone (Reactor A). The discharge from Reactor A entered a large lagoon reactor (3,000 m<sup>3</sup>) with a small anoxic zone and a large aerobic zone (Reactor B). The discharge from Reactor B entered the clarifier for solids separation. The recycled activated sludge (RAS) from the clarifier was returned to Reactor A. The waste activated sludge (WAS) was wasted to the anaerobic lagoon.

Nitrogen removal is generally the key constraint when treating rendering plant wastewater. The BNR system as shown in Figure 1 utilises a combination of separate and simultaneous nitrification and denitrification processes. However, due to the high concentrations of nitrogen present in rendering plant wastewater, a high level of system control and operation is required to ensure that efficient nitrogen removal is maintained at all times.

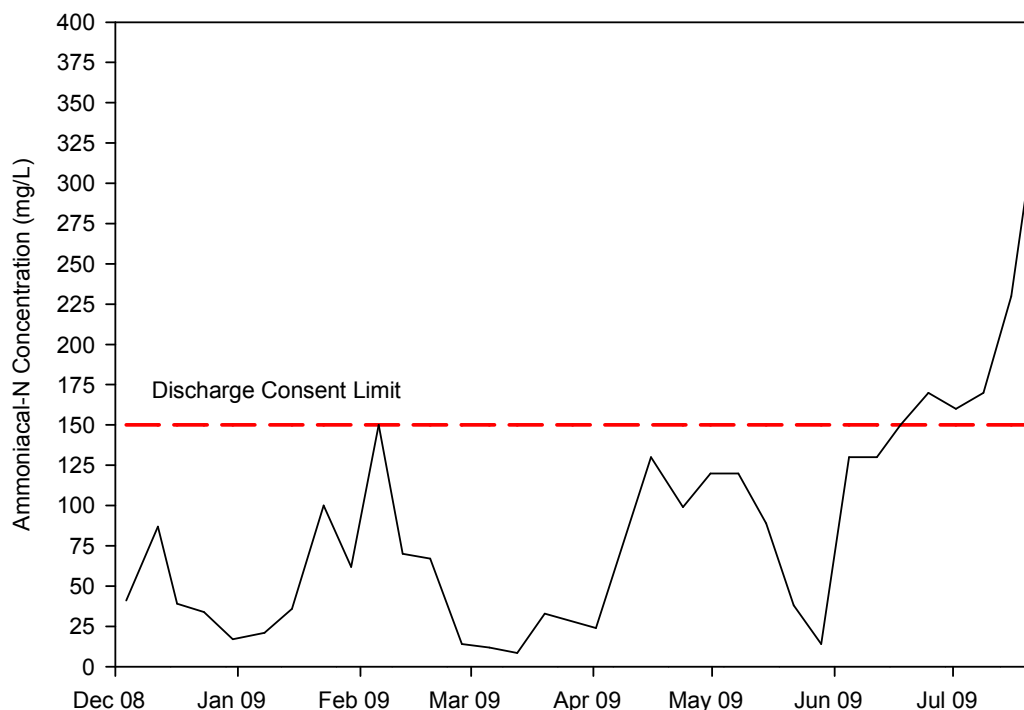
In addition to objectionable odour production from Reactor A, ammoniacal nitrogen levels in the final treated effluent were increasing beyond the compliance limits on a regular basis, as detailed in Figure 2.

Figure 2: Treated Wastewater Ammoniacal-N Concentrations Pre-Failure

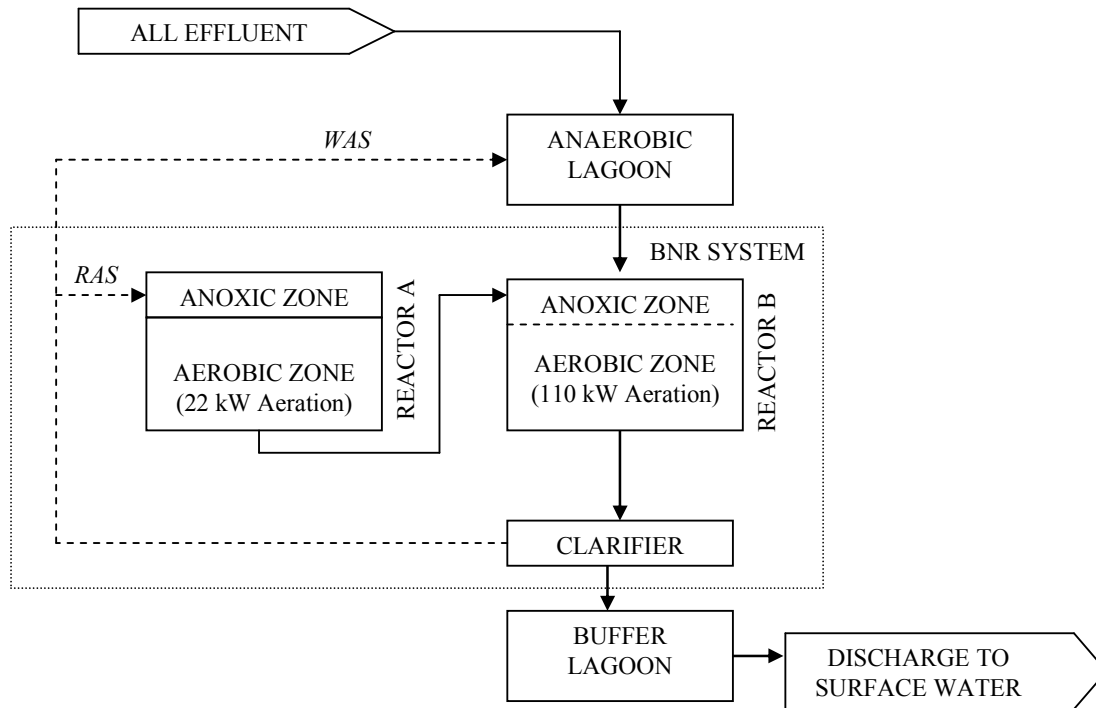
The initial steps were to turn off the aeration supply in Reactor A as the diffused aeration was assisting in the air stripping of the odour generating compounds, increasing the adverse odour effect. Following this, the anaerobic effluent was diverted to Reactor B, while the RAS was continually pumped into Reactor A. After a period of 2-3 hours, aeration of Reactor A was re-started, when the tank had been sufficiently diluted to prevent further air stripping of odour generating compounds. With no anaerobic effluent entering Reactor A, the two BNR reactors were run in parallel.

The “technical fix” configuration for immediate recovery of Reactor A is shown in Figure 3.

Figure 3: BNR System Reconfiguration Immediately after Process Failure

The effect of this modification was a drop in odour levels within an hour of the re-configuration, even when Reactor B faced a substantial increase in wastewater load. Because the actions taken to prevent the odours did not significantly improve the system performance, in terms of nitrogen removal, further follow-up investigations were required to establish the cause of the BNR system process failure.

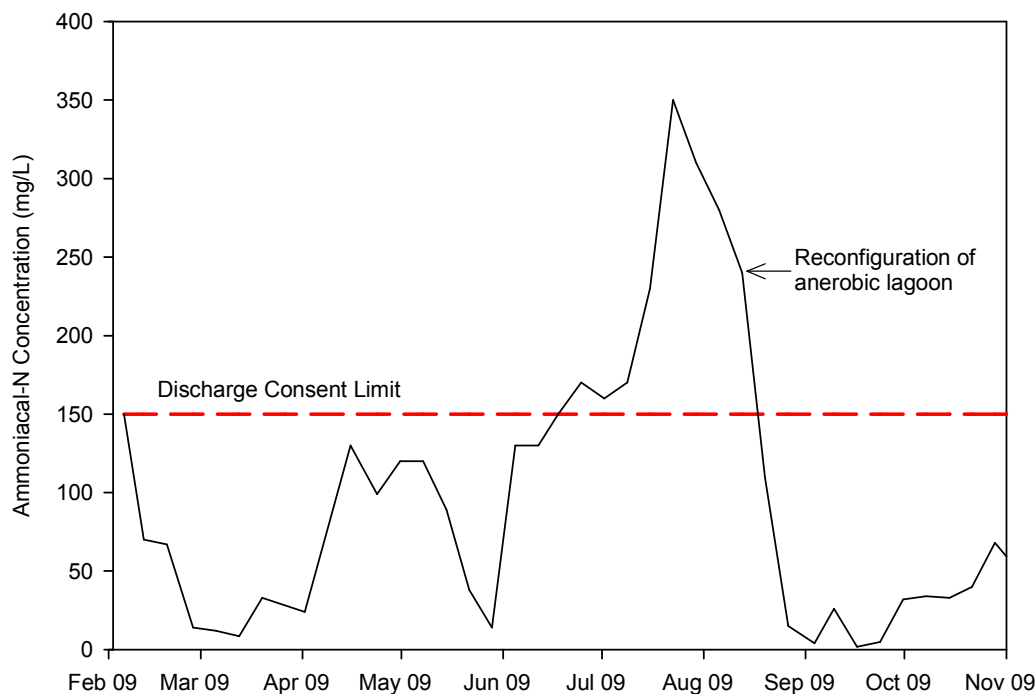
The investigation was then focused on the anaerobic lagoon and its operation. With the assistance of the rendering plant staff, some short circuiting of the wastewater flows within the anaerobic lagoon was identified. An upgrade of the anaerobic lagoon had occurred in the previous two years, which had included the installation of a floating cover and gas flare system, and the installation of a series of inlet manifolds along the base of the lagoon. A new self priming discharge pump was also installed and initially operated on level control. Since the upgrade of the lagoon, the inlet manifolds experienced frequent blocking, requiring regular cleaning. However, when the manifold system experienced excessive blockage, the incoming wastewater would overflow into a by-pass pipe and enter the lagoon via three inlet pipes that had historically been the lagoon inlet. One of the inlet pipes, however, was situated in close proximity to the new lagoon outlet, resulting in the short circuiting of the anaerobic lagoon.

To overcome the blockages and short circuiting, the manifold system was decommissioned. The original inlet pipes were re-commissioned with the inlet nearest to the anaerobic lagoon discharge pump blocked off. The isolation of the short-circuiting in the anaerobic lagoon substantially improved BOD removal in the anaerobic lagoon, with more than 80% BOD removal, and a rapid improvement in nitrification was experienced. This resulted in a rapid reduction of the ammoniacal nitrogen levels in the treated effluent, to well below the compliance limit, as shown in Figure 4.

Figure 4: Treated Wastewater Ammoniacal-N Levels post-Anaerobic Lagoon Upgrade

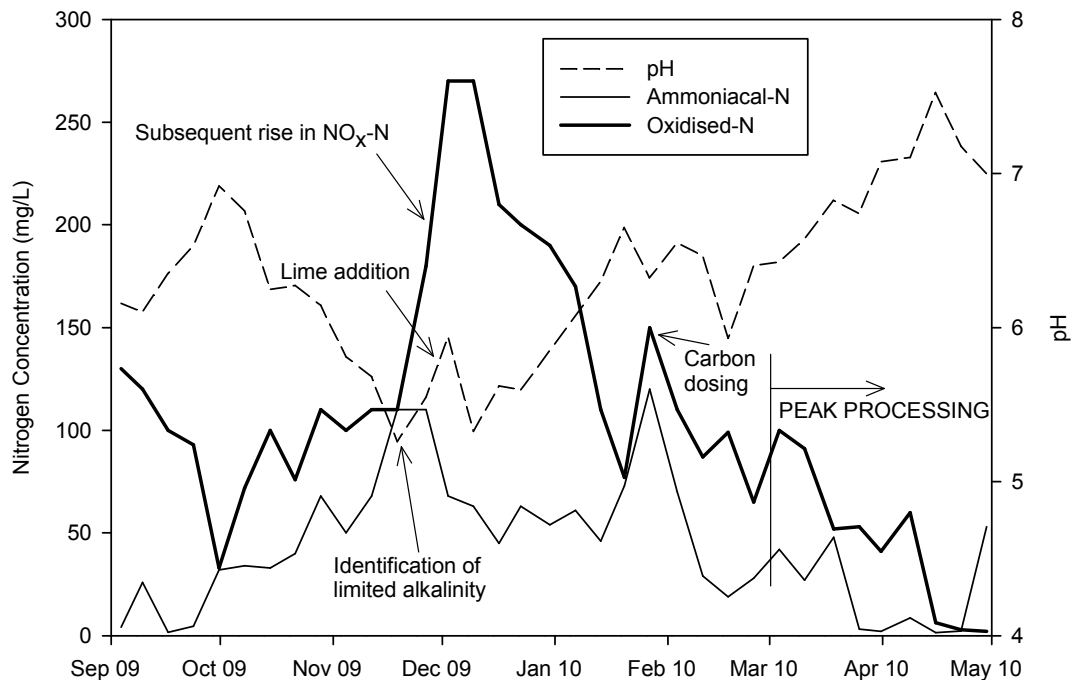
Monitoring of the anaerobic effluent indicated that characteristically the BOD:N ratios in the effluent were between 1:1 and 2:1, well short of the generally accepted minimum BOD:N ratio for nitrogen removal of 3 to 3.5 (Henze *et al.* 2002). It was noted that previously, under normal operation, supplementary carbon was supplied at an uncontrolled rate from several identified internal carbon sources, that were available from the rendering plant. Seasonal variations in rendering plant operation resulted in a limited supply of the supplementary carbon source waste stream, which was identified as the cause of the impaired nitrogen removal, potentially contributing to historical events of poor nitrogen removal. The depletion of available carbon for denitrification and the impact of the alkalinity augmentation during the BNR plant optimisation is demonstrated in Figure 5.

Figure 5: BNR Plant Performance during Low Carbon Conditions

In order to ensure that sustainable nitrogen removal was accomplished, a suitable external carbon supply was secured and added to the BNR Reactor B at controlled rates when required. Reactor B was changed back to pH control of aeration and the pH was maintained between 6.0 and 6.7 pH units, based on the optimum pH zone for nitrification and denitrification [Henze *et al.*, 2002] for the reactor ammoniacal-N concentrations received from the anaerobic lagoon. Daily carbon dosing decisions were then made based on anticipated rendering plant processing rates, and the ammoniacal-N and nitrate-N content in the discharge from Reactor B. While carbon dosing was conducted during times of reduced processing, once peak processing season started carbon dosing was no longer required.

Dosing of externally supplied carbon during the period of reduced rendering plant operation, had an improved effect on the performance of the BNR plant (as shown in Figure 5). The nitrate-N levels were able to be maintained at acceptable levels and alkalinity augmentation was not required to maintain nitrification. Carbon

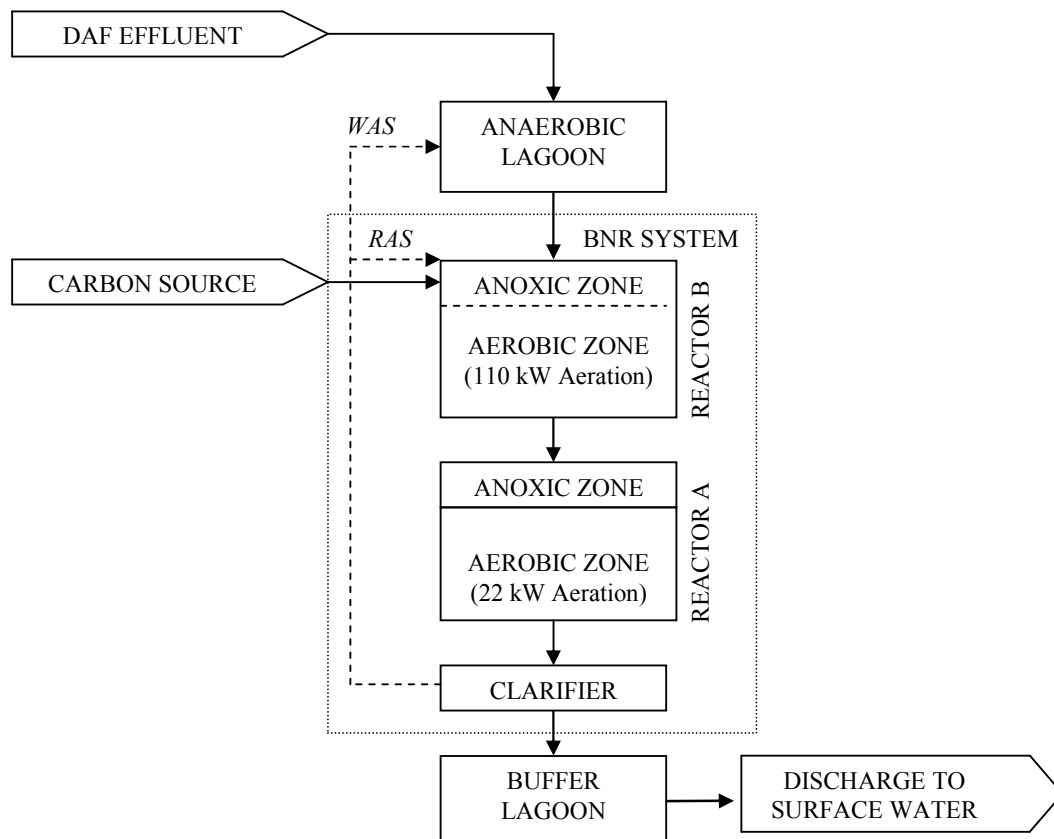
The post-failure reconfiguration of the BNR reactors, as a result of the odour emissions from Reactor A, meant the BNR reactors were operating in parallel for a period of time. While sufficient nitrogen removal was being maintained, much of the wastewater was not being treated in Reactor A and effluent polishing of all wastewater was not being realised. The BNR system was then reconfigured to provide for Reactor A to be operated in series, following Reactor B, without any internal/external supply of carbon into Reactor A. The optimised configuration of the BNR system is shown in Figure 6.

Figure 6: Optimised Reconfiguration of BNR System

The reconfigured system has the process trains reversed from the pre-optimisation system where the larger Reactor B receives all the anaerobically treated effluent and Reactor A is now utilised for polishing prior to discharge. This configuration provides the rendering plant with a large amount of security as there is lesser potential for shock loading the of larger BNR reactor.

Ongoing operation of the reconfigured system identified that the Reactor B was consistently capable of removing the majority of the nitrogen from the wastewater, with effluent ammoniacal-N concentrations of approximately 50 mg/L and nitrate-N levels of 80 mg/L during peak rendering plant processing.

The key outcome of this component of the system optimisation was that the larger, Reactor B was capable of achieving similar nitrogen removal rates as the parallel system and that by operating the reactors in series, with Reactor A following Reactor B, additional nitrogen removal was enabled as well as providing better settleability of the solids in the clarifier. The major benefit of the optimisation programme was that excellent nitrogen removal rates, of over 90% removal, were achieved without any major plant upgrades or capital expenditure.
