INNOVATIVE STORMWATER TREATMENT ASSET CONVERSION AT AUCKLAND MOTORWAYS

Troy Brockbank¹, Peter Mitchell², Rob Hannaby³

¹ Stormwater360 New Zealand, ² Auckland Motorway Alliance, ³ New Zealand Transport Agency

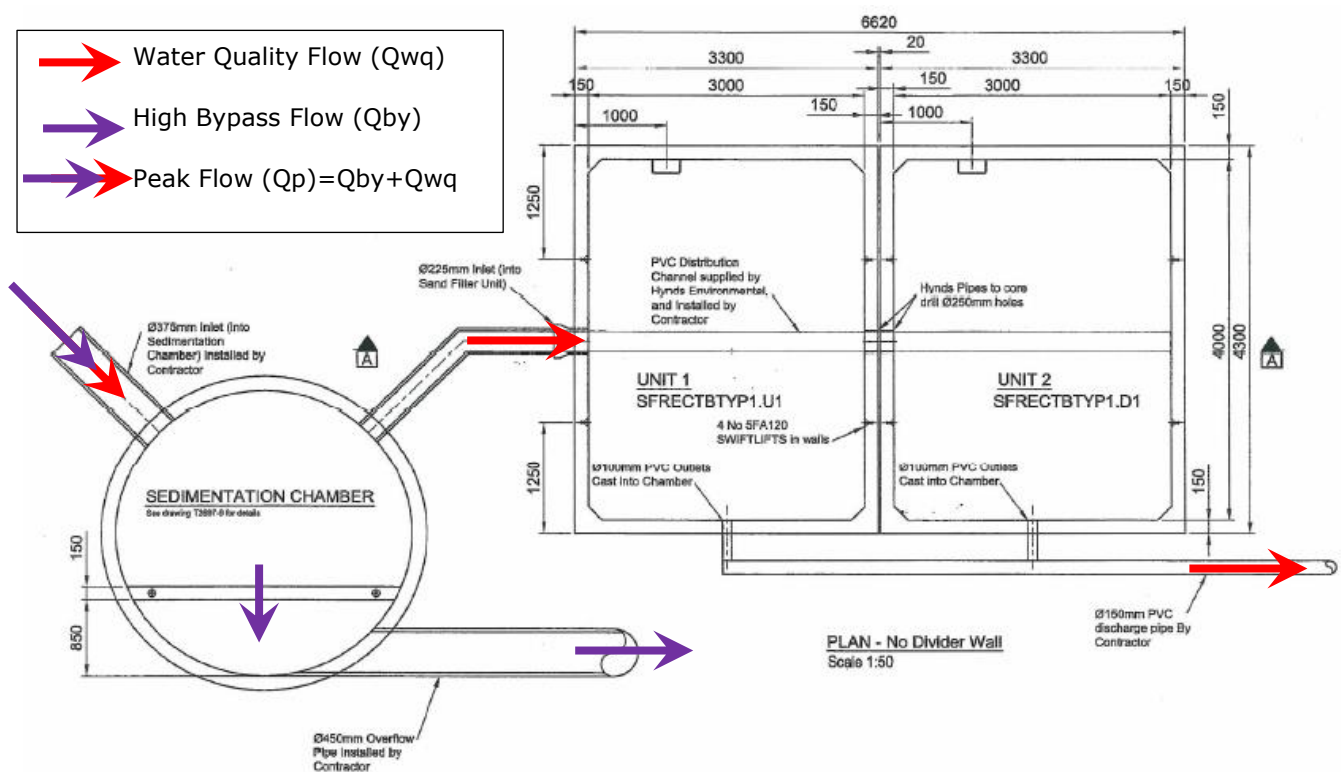
Figure 2: Original Sandfilter Layout Plan (Amended from Source: Hynds Environmental)

Stormwater runoff entered the stormwater reticulation network through traditional roadside catchpits located along the SH1 Luke St northbound off-ramp and associated auxiliary lane. Peak flows were discharged via piped reticulation to an offline configuration sandfilter treatment system, consisting of an upstream pre-treatment sedimentation chamber, and two downstream conventional sand filtration treatment chambers (Figure 2).

Peak influent flows entered the pre-treatment sedimentation chamber, a 3.2m dia manhole, via a 375mm reinforced concrete pipe (RCP) inlet. The chamber provided primary settling and capture of large/coarse sediment particles during low flows, up to Water New Zealand’s 2017 Stormwater Conference

and including the water quality flow (Qwq). Low flows exited the chamber via a 225mm diameter RCP outlet, located 910mm below the inlet pipe, and discharged to the downstream filtration chambers for treatment. The internal base of the sedimentation chamber was located 390mm below the low flow outlet invert, and provided a permanent water sump to aid sediment storage and prevent resuspension of collected material. A weir, with top of weir located 300mm above the inlet pipe invert, spanned the width of the chamber and provided for an offline peak diversion bypass for high flows greater than the water quality flow. High flows were then discharged via a 450mm dia RCP to a downstream manhole prior to outfall.

The main sand filtration treatment was contained and spread across two proprietary pre-cast concrete modular box culvert units; each having a 3m x 4m internal footprint. Untreated influent entered the first filtration unit onto a 200mm dia half pipe PVC channel, which provided distribution of influent evenly across both units. Treatment was provided by filtering influent through a 400mm layer of sand, beneath the distribution channel, upon geotextile. A 2.05m ponding layer, located above the distribution channel, provided live storage attenuation of incoming flows and ensured that the total water quality volume passes through the filter without bypass. The ponding layer depth also provided hydraulic driving head to aid percolation through the treatment sand layer. A 100mm dia perforated pipe manifold, located in a 150mm thick drainage aggregate layer, provided for collection of treated stormwater prior to discharge through a solid 100mm dia PVC outlet into an external 150mm PVC manifold. Treated effluent eventually discharged via a 450mm dia RCP to a wingwall outfall located on the banks of the Ōtāhuhu Creek.

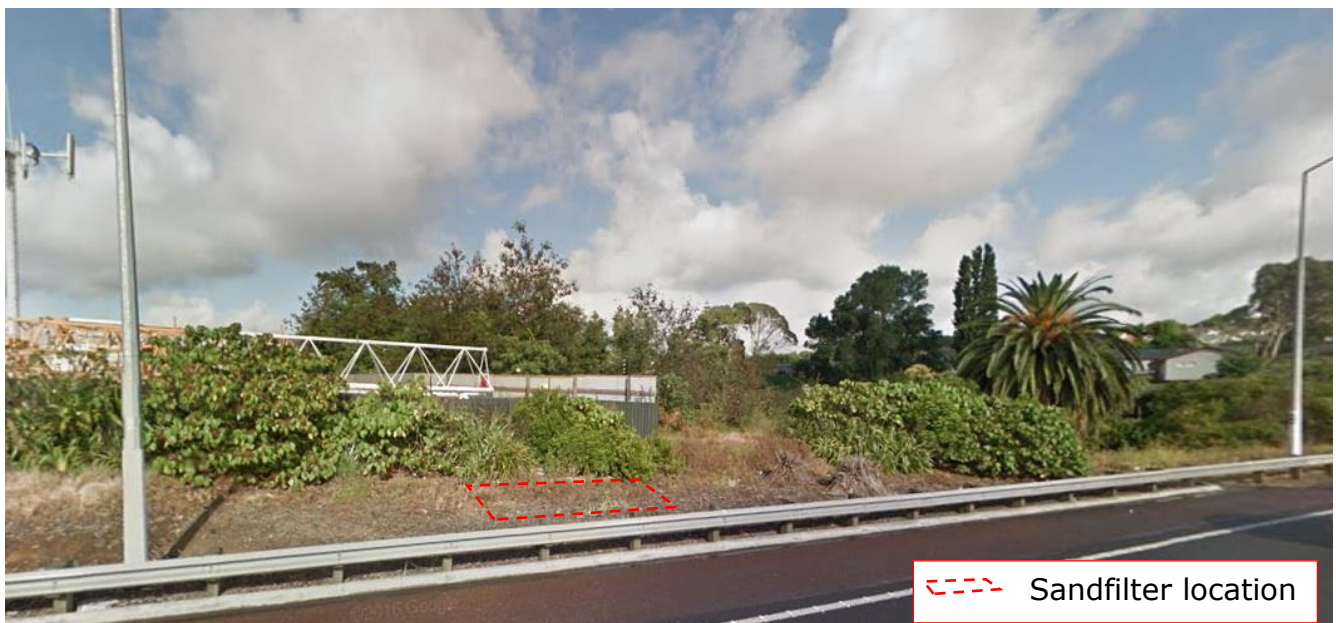
Figure 3: View of Sandfilter site from motorway 2012 (Source: Google)

Maintenance activities needed to be undertaken at night as a w-section guardrail (Figure 3), running along the adjacent motorway, prevented vehicle access to the asset. This meant traffic control was required to close the motorway shoulder and divert traffic from the adjacent lane during every maintenance activity. These closures were typically implemented over consecutive nights (typically 3-4) to allow time to undertake maintenance, which resulted in a loss of motorway network efficiency and availability for road users.

A new opening in the existing w-section guardrail (Figure 7) has been installed to facilitate vehicle access to the asset without the need for a full lane or shoulder closure, and also allows maintenance activities to be undertaken during the day.

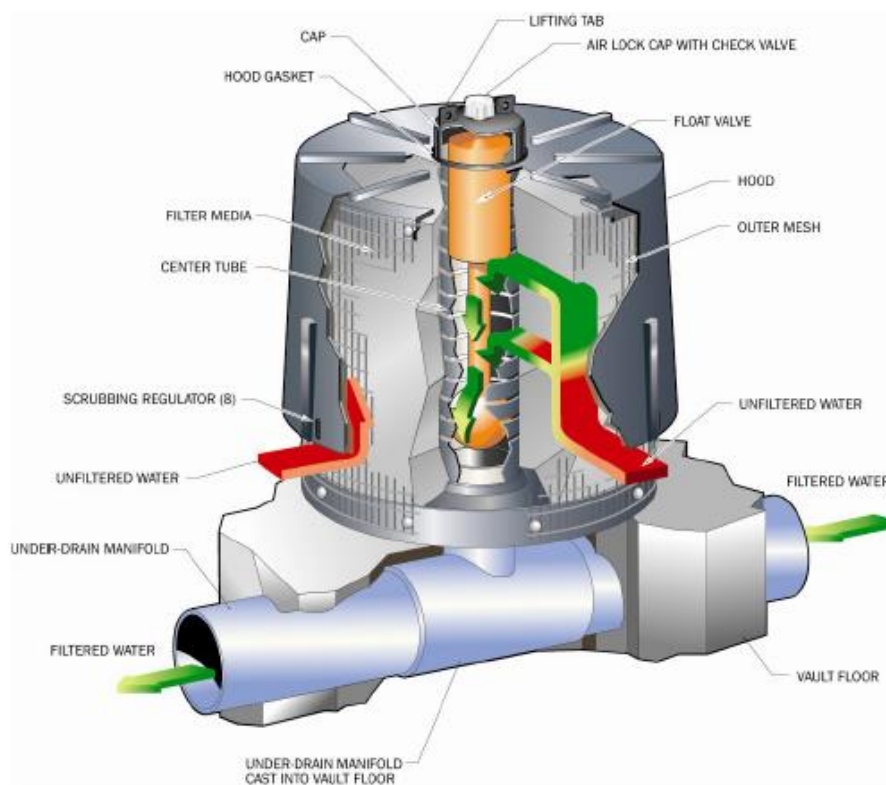
Figure 4: StormFilter Cartridge

The StormFilter is a proprietary stormwater treatment device distributed in New Zealand by Stormwater360. The device utilises radial media cartridge filters (Figure 4) to passively filter stormwater runoff, capturing particulates, and adsorbing materials such as dissolved metals and hydrocarbons (Hannah, 2012). The StormFilter is an Auckland council approved treatment device for removing >75% total suspended solids on a long term annual basis (Afoa, et al., 2015).

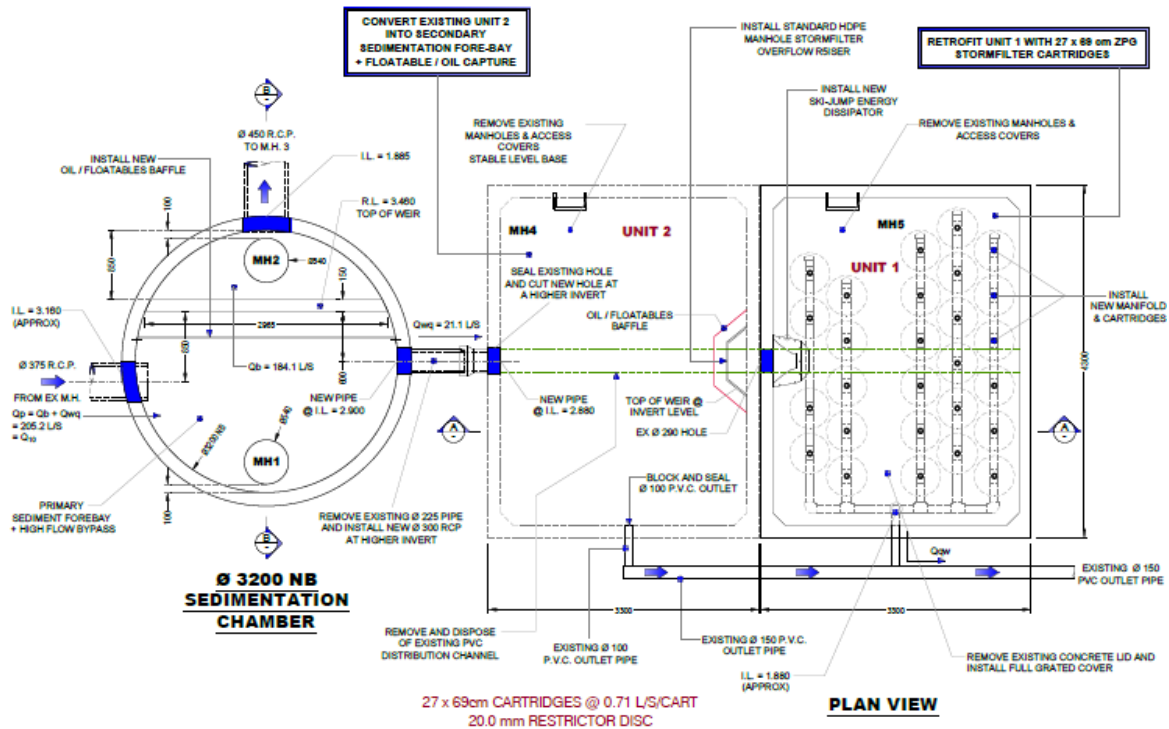
Figure 5: Retrofit (StormFilter) Layout Plan (Source: Stormwater360)

Peak flows from the upstream catchment are discharged via piped reticulation to an offline configuration StormFilter treatment system, consisting of an upstream pre-treatment sedimentation chamber, a new secondary forebay and StormFilter treatment bay (Figure 5).

The sedimentation chamber was retained to provide primary settling and capture of large/coarse sediment particles during low flows, up to and including the water quality flow (Q_{wq}). The low flow pipe has been raised to provide for an extended 1m sump, and upsized from a 225mm RCP to 300mm RCP to aid floatables flowing into the downstream units. A new baffle will help prevent oil & floatables bypassing over the high flow diversion weir.

The directly downstream vault unit 2 has been retrofitted to a large forebay to provide secondary sedimentation to remove coarse particles. A weir structure has been installed on the outlet to raise the permanent water level in the unit and to provide a 1m sump. A baffle has been installed on the outlet structure to aid in capture of floatables and prevent discharge to the downstream filtration unit 1.

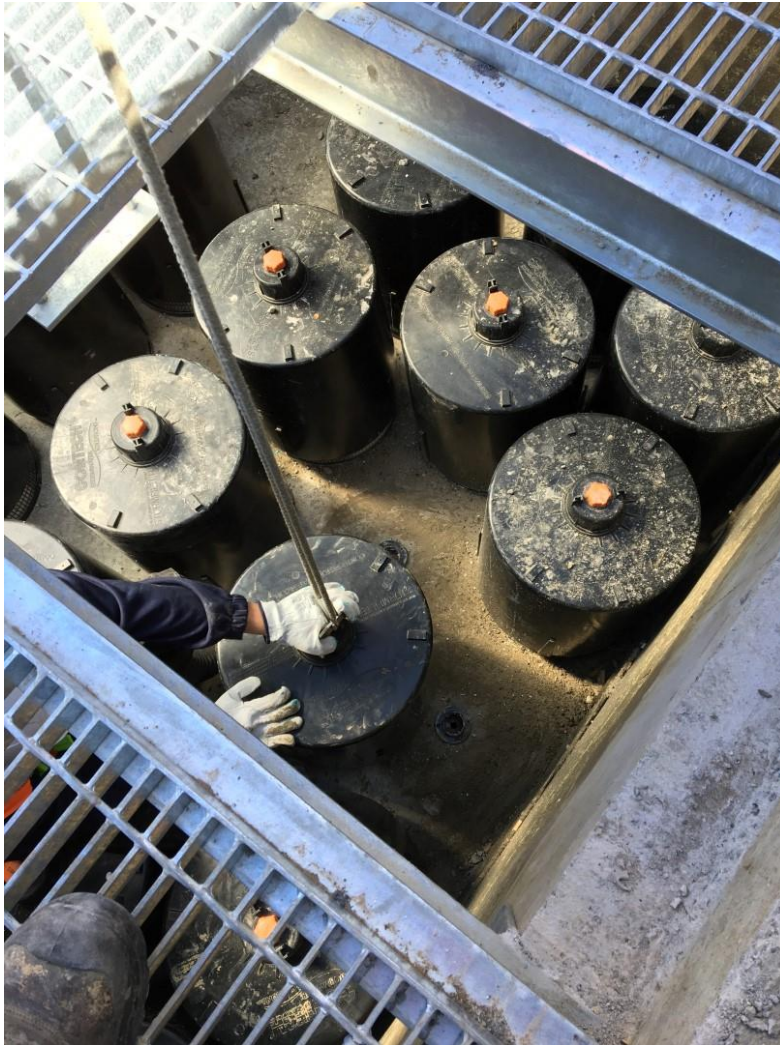
Figure 6: Installing StormFilter Cartridges (Source Stormwater360, 2016)

Unit 1 has been retrofitted with 27x69cm ZPG media StormFilter cartridges (Figure 6) to provide stormwater quality treatment in accordance with the resource consent conditions. This required only minor modifications, primarily underdrainage related to the existing structure.

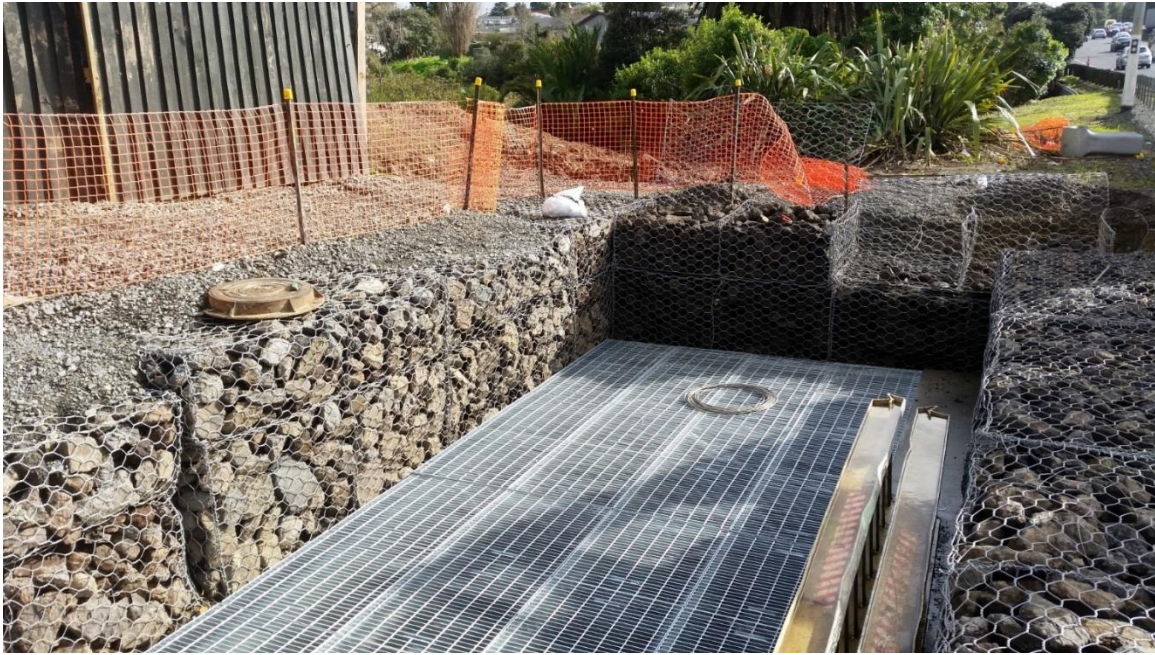
Figure 8: Grated top of StormFilter Retrofit (Source: T Brockbank, 2016)

A significant improvement has been the removal of the original concrete lid and replacement with a webforge grating (Figure 8). This feature will help to reduce the risks associated with confined space entry by; decreasing the need for an confined space entry ie visual inspection can be undertaken from above without entering asset, decreasing risk of gas exposure, accumulated highly toxic gases and associated need for venting, and increasing visual contact with confined space entrant and better access points for rescue.

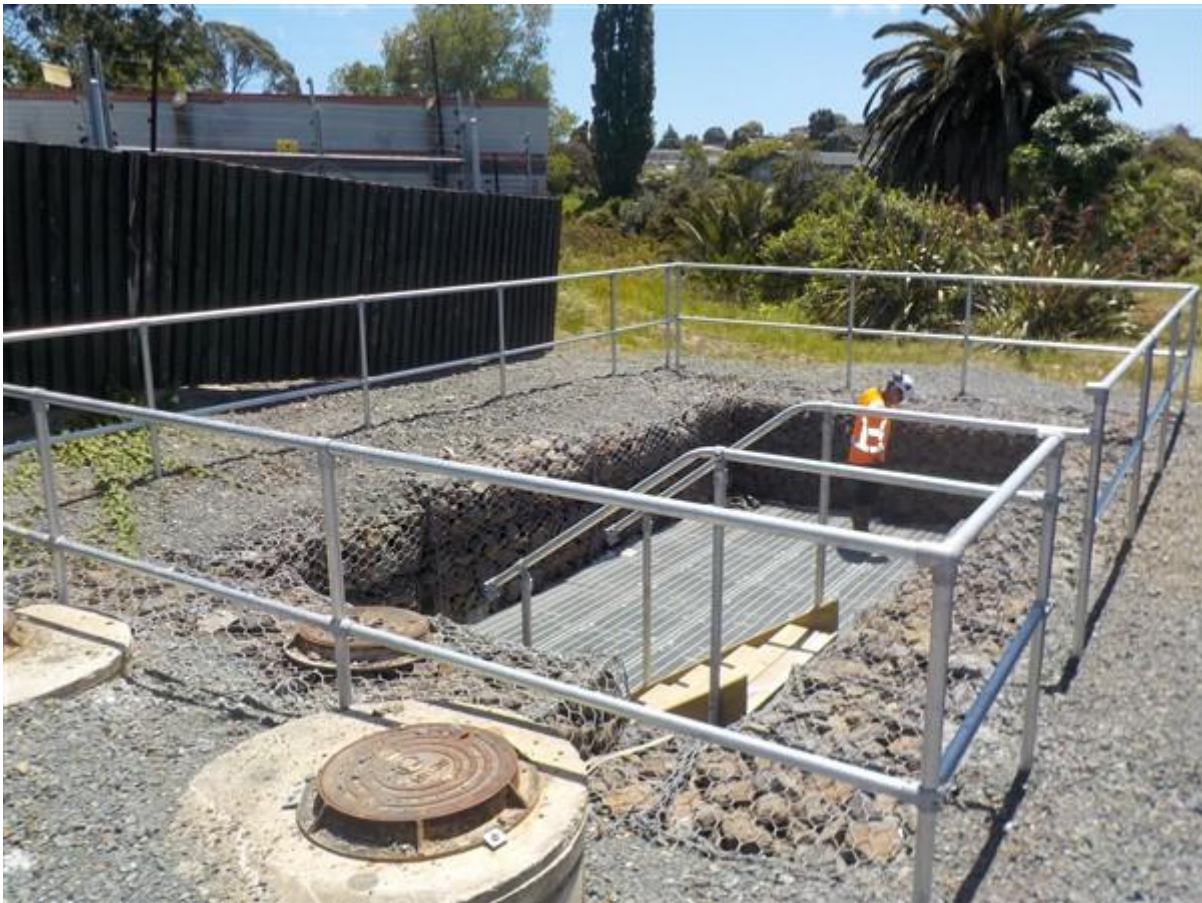
Figure 9: Handrails installed on StormFilter Retrofit (Source: Stormwater360, 2016)

Handrails (Figure 9) have been installed on the perimeter to the asset to help prevent falls from heights into the device.
