RENEWING SEWERS AND STORMWATER CONDUITS– WHAT CAN AND CAN'T BE LINED

John Monro, Interflow Pty Limited

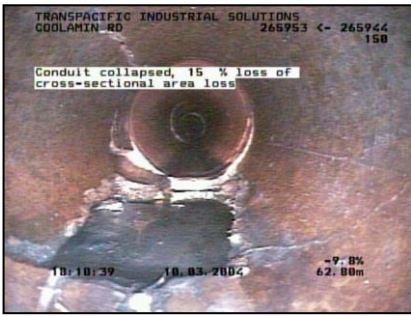
Picture 1: Sewer with missing section

As the liner is installed in a rigid condition it will structurally span the missing wall section in Picture 1. The liner will be circular and not attempt to bulge at that location.

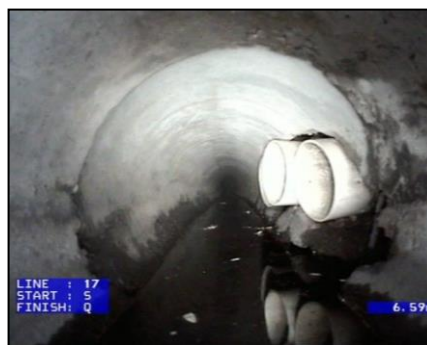
Picture 5: Intruding lateral junctions

Intruding lateral junctions require removal by grinding with a robotic cutter.

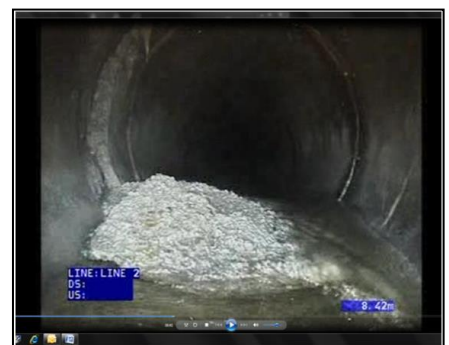
Picture 6: Debris, possibly silt, rubble or concrete

If the debris in Picture 6 is rubble or silt, it could be removed by jetting. If it is found to be concrete, milling using a high capacity hydraulic milling machine will be needed to clear the line.

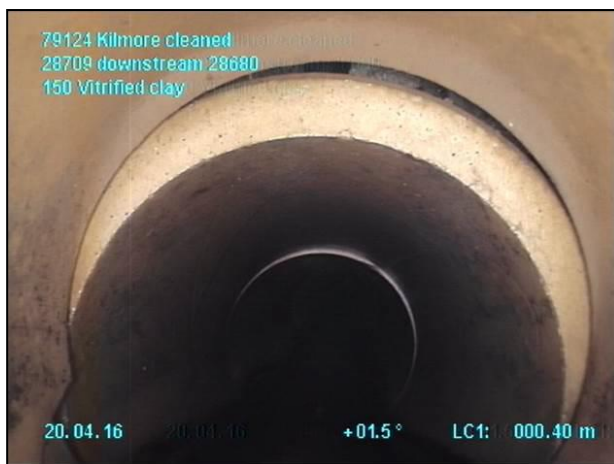
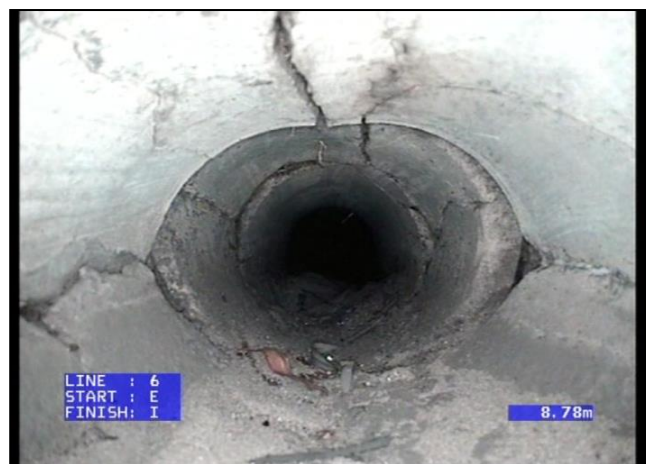
Picture 7: Displaced or dropped joint

Picture 8: Deformed pipe, partial collapse

Installation of a spiral wound liner would be possible through these defects, although grinding may be needed at the displaced joint to remove the sharp edge. However, the conditions at these defects mean that the full diameter of the liner will not be achieved. Installation will not proceed unless the Client agrees that this is acceptable.

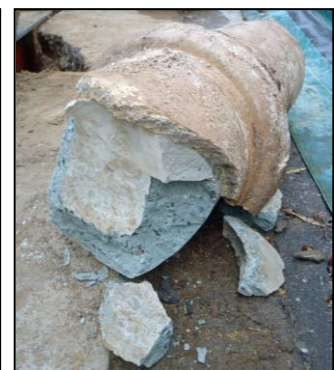
Picture 9: Broken pipe or joint with excessive displacement

Picture 10: Collapsed section of pipe

Picture 11: Pipe filled with concrete

Sewers with the following defects cannot practically be lined without a local repair being performed. This involves excavation then removal of the defective section and installation of a section of new pipe.

If the defect is due to age or deterioration, then a liner can be installed along the entire sewer length from manhole to manhole, including continuously through the newly repaired section. This will effectively renew the entire length.
