THE HAMNAK PIPELINE – NEW ZEALAND’S LONGEST PVC-O WATER TRANSMISSION PIPELINE

A. J. Roy, Iplex Pipelines NZ Ltd, New Zealand

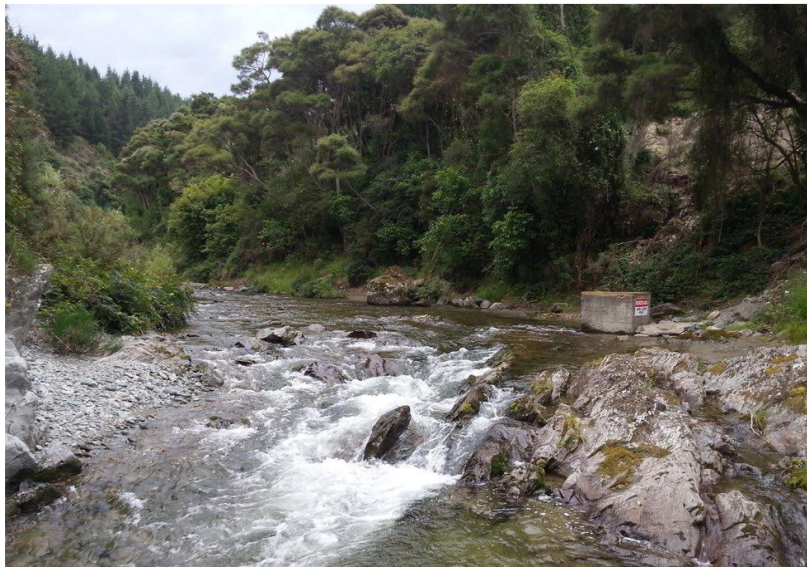
*Photograph 1: Former Herbert-Waianakarua water supply intake (Normal conditions)
(Image courtesy – Waitaki District Council)*

- Vulnerable to drought & flood events resulting in frequent supply restrictions (refer to Photographs 1 & 2).
- Undersized for future population and business growth.
- Maintained and governed by local water scheme operators.
- Reaching end of life and susceptible to failures.

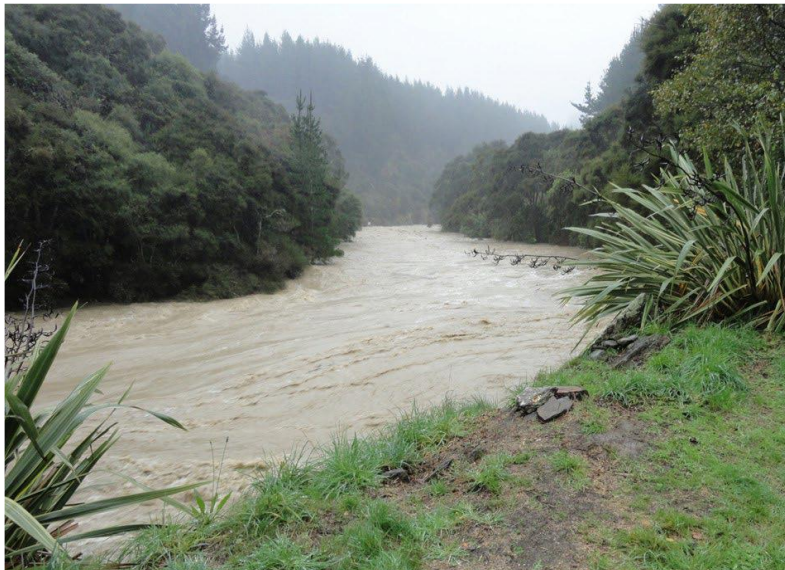
*Photograph 2: Former Herbert-Waianakarua water supply intake (Flood Conditions)
(Image courtesy – Waitaki District Council)*

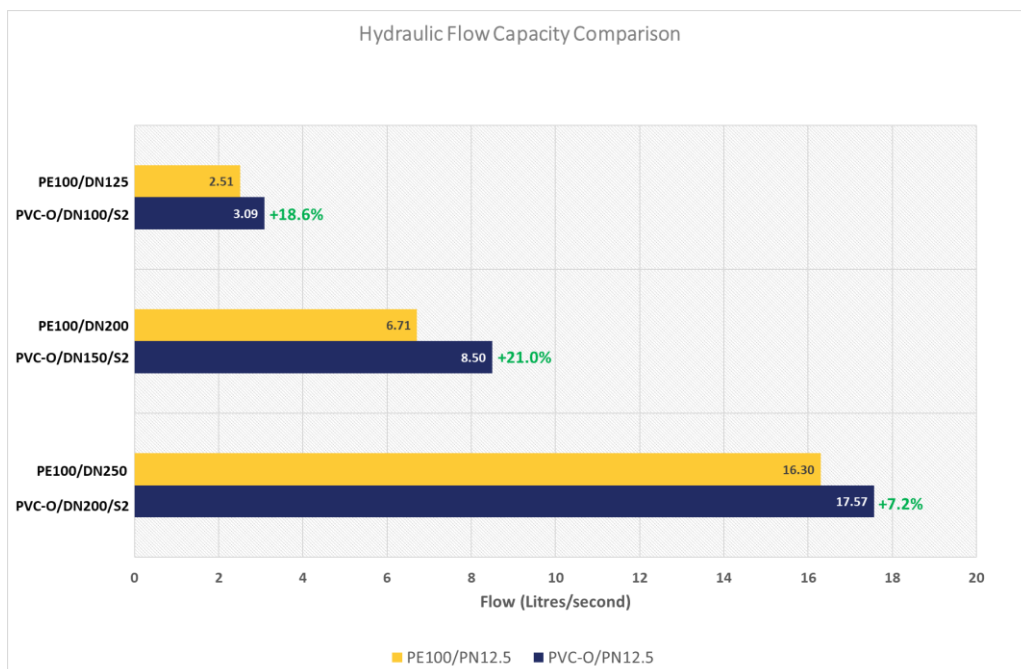
A simple comparison of hydraulic flow capacities carried out based on the Lamont S3 formula (O’Callaghan, 1983) using a Hydraulic Gradient (i) of 0.001 and assuming full bore flow illustrated the advantages of PVC-O as an alternative material over a similar nominal diameter of PE100 pressure pipe. This is shown on Figure 3.

Figure 3: Hydraulic flow capacity comparison for given material choices

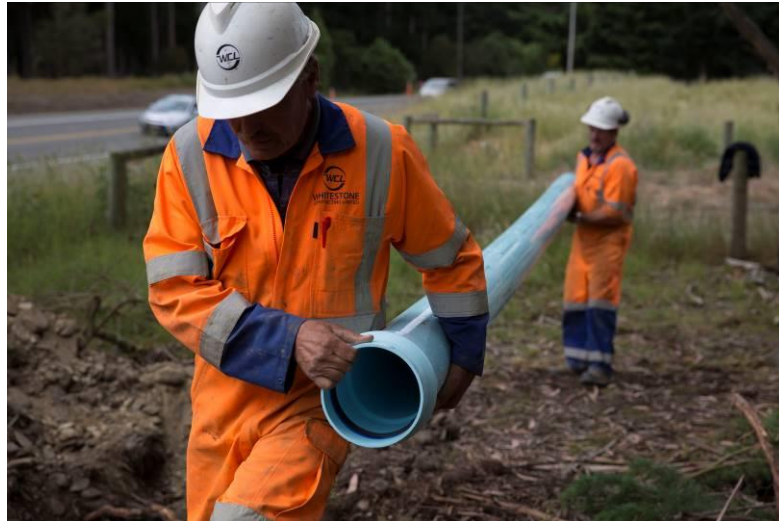
*Photograph 4: Site handling a 6.5 m length of DN200 Series 2 PVC-O
(Image courtesy – Iplex Pipelines NZ Limited)*

The Contractor had two (2) pipelaying crews operating to ensure that pipelaying continued at pace (up to 200 metres/day dependent on conditions). The open-cut methodology, combined with light weight pipe, enabled quick installation and reinstatement of excavations as the work face advanced through. Typical examples of pipelaying activities with PVC-O pipe are shown in Photographs 4 to 6.

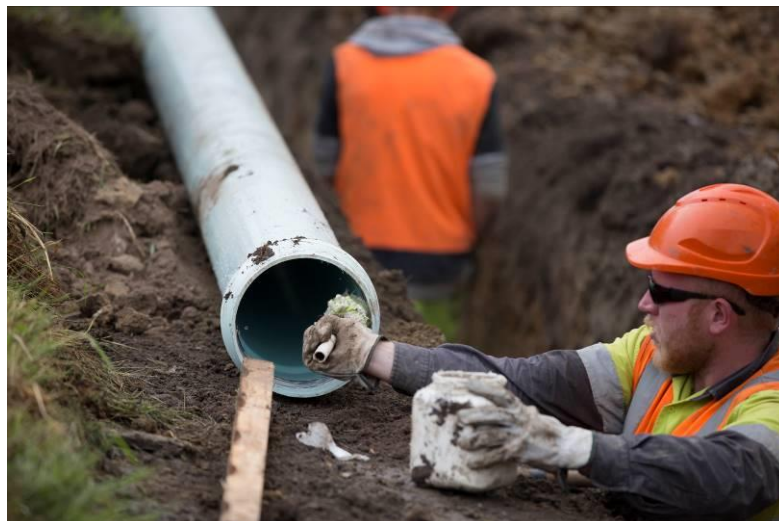
*Photograph 5: Application of bactericidal pipe jointing lubricant to the locked-in-place
seal ring
(Image courtesy – Iplex Pipelines NZ Limited)*

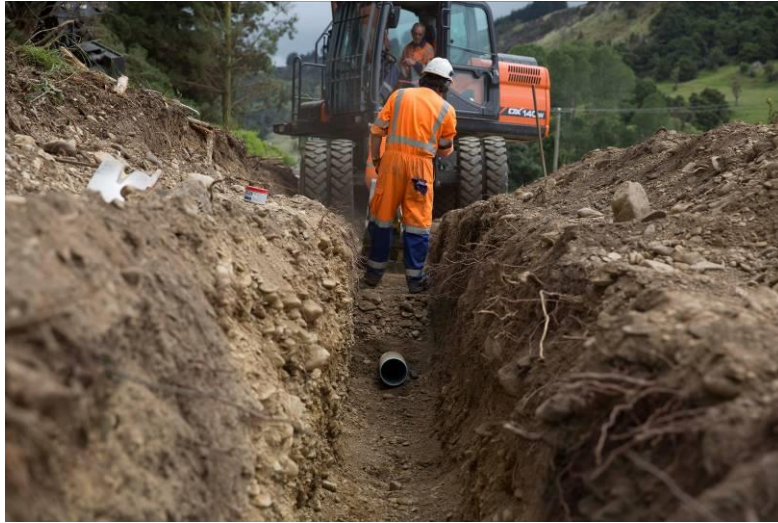
*Photograph 6: Compaction of embedment zone above pipe
(Image courtesy – Iplex Pipelines NZ Limited)*

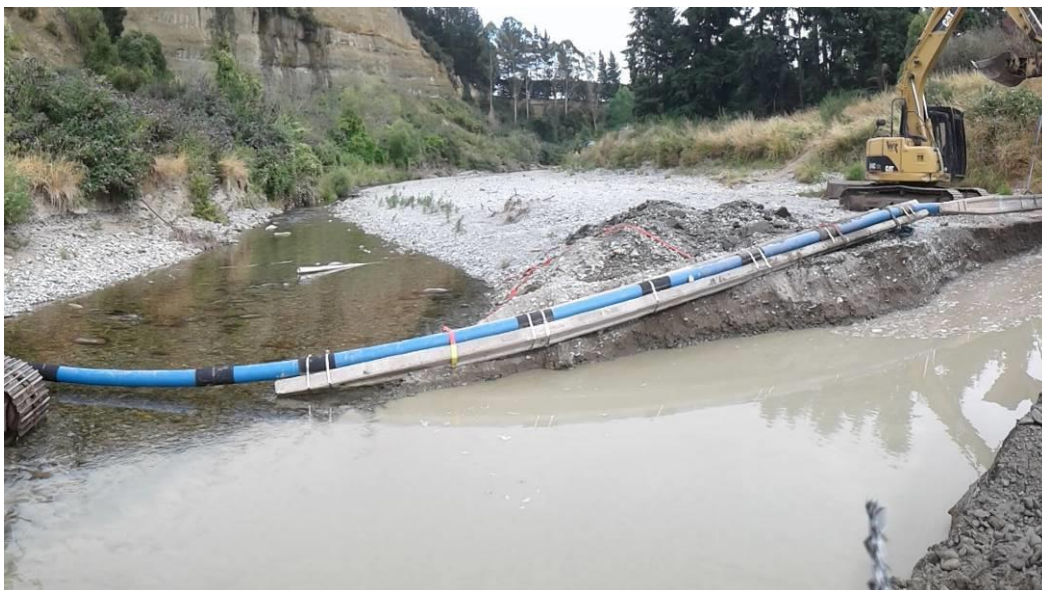
In the case of the Waianakarua River crossing where open excavation was used to install the pipeline, the Contractor gained engineering approval to install the PE100 DN180 pipeline section using an innovative methodology. Eight (8) repurposed concrete power poles were strapped onto the PE100 pipe with rubber sheathing to protect the pipeline as shown on Photograph 7. This prevented the pipeline from floating, during placement in the excavation. The challenging site conditions included both mobile alluvial river bed materials within a sandstone dish – and a continuously flowing river.

*Photograph 7: Waianakarua River Crossing utilising concrete poles for anchorage.
(Image courtesy – Waitaki District Council & Whitestone Contracting)*

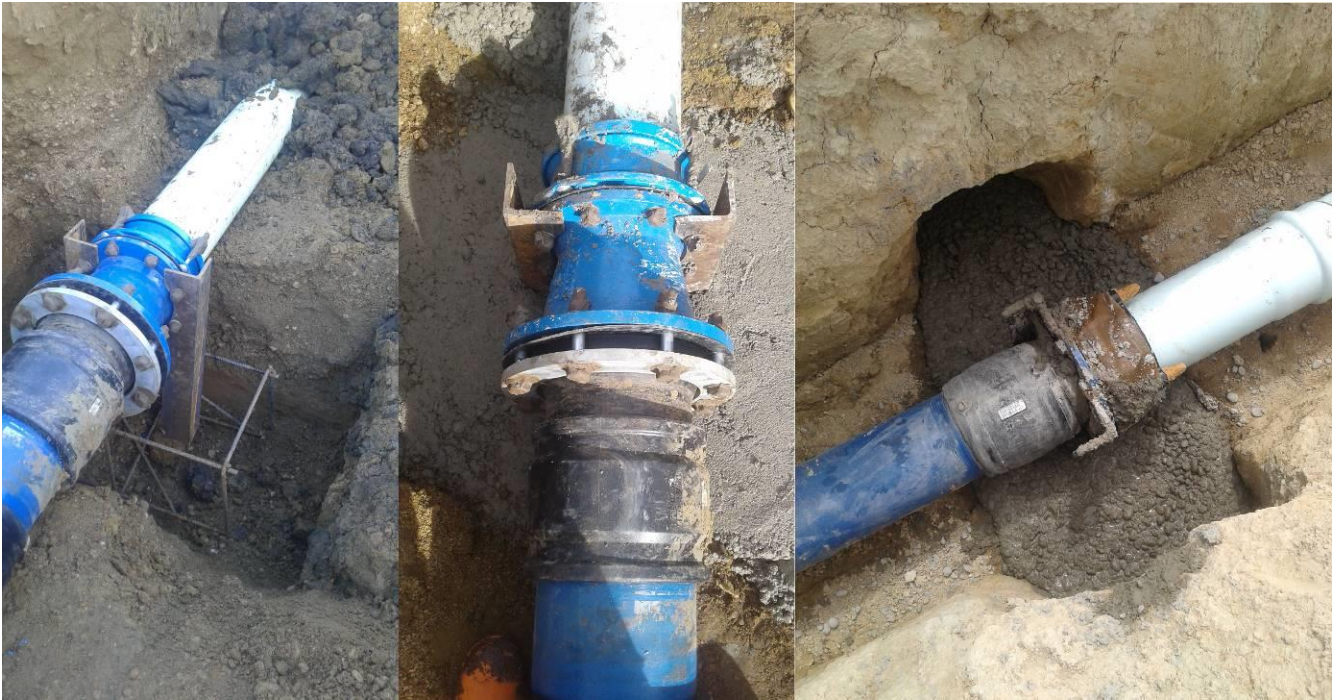
Special accommodations were made for PE to PVC transition connections – wherein the Ductile Iron flange assembly on the PVC side was secured onto vertical brackets permanently set into a large concrete anchor-block under the assembly. The anchor block extended a minimum of 300 mm past the trench walls on both sides supported against undisturbed ground. This provided post-installation surety that the assembly was well restrained and protected against lateral movement. Examples of how this was achieved in the field are shown in Photographs 8 to 10.

Photographs 8, 9 & 10: PE to PVC Flange transition joint assemblies with associated restraint brackets.
