3WATERS DELIVERY ON THE CHATHAM ISLANDS – MAXIMISING OPPORTUNITIES

A. Wong, K. Norquay*, O. Pickles#*

**Stantec New Zealand*

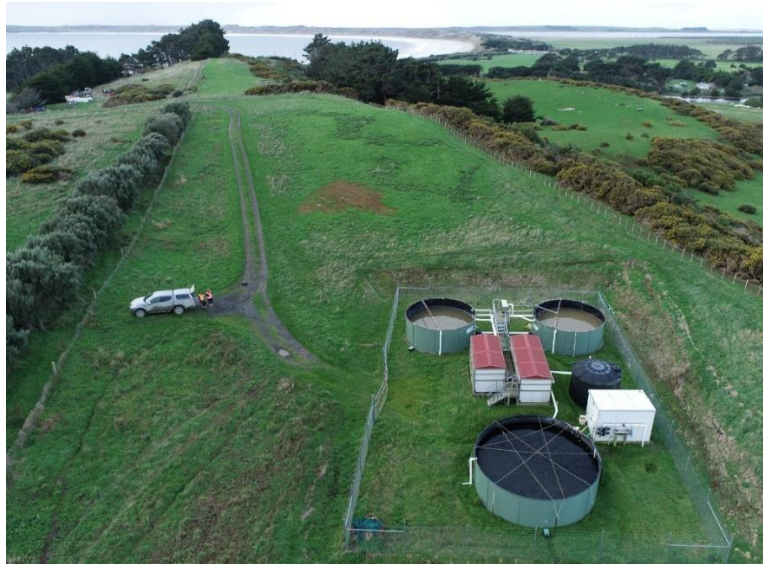
Treatment Plant (WWTP). At the WWTP, the wastewater passes through a mechanical inlet screen into one of the two flow balancing tanks, prior to being pumped to the Rotating Biological Contactor (RBC) units for biological treatment and a lamella plate settler for clarification. The clarified wastewater is collected in the Final Holding Tank. The settled particles from the clarifier are pumped to a waste sludge tank, with the supernatant returned to the inlet and settled sludge periodically removed and disposed off-site. From the Final Holding Tank, the wastewater is pumped through disc filters before entering the UV unit for disinfection. The treated wastewater is irrigated to land at the WWTP site.

Figure 1: Waitangi WWTP

Except for the two Balance Tanks and two RBCs, the design of the WWTP is based on a duty-only philosophy. This was to provide an affordable solution that was simple to operate and maintain. Since 2005, Waitangi's wastewater system has been left unchanged, except for minor repairs and replacements (i.e., pump refurbishments, UV lamps, UV ballast). Significant repairs to the system were identified in CIC's Strategy.

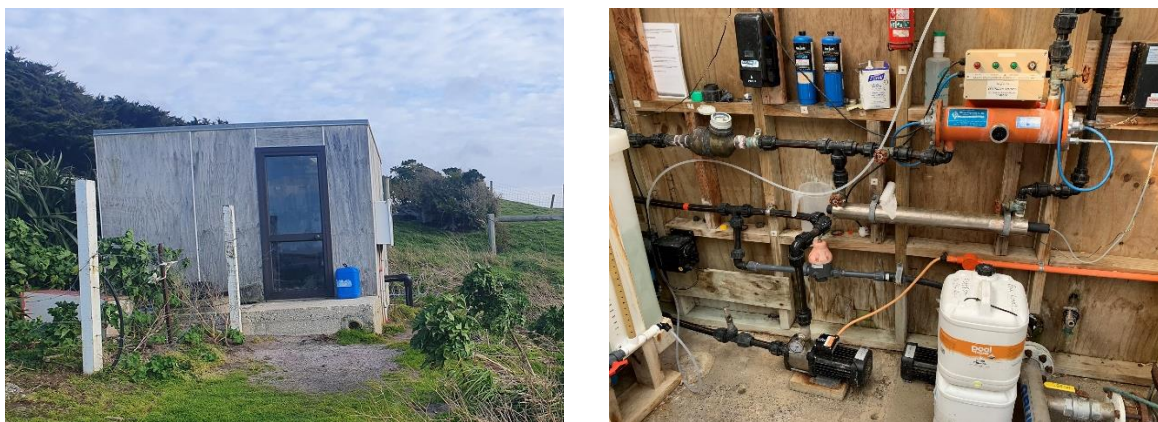
The raw water is pumped from the Tikitiki bore to the Waitangi Water Treatment Plant (WTP), where it passes through a multimedia filter and softener. Disinfection is provided by two parallel UV reactors, as well as secondary disinfection using sodium hypochlorite for chlorination. The treated water flows into the Tikitiki Reservoir adjacent to the WTP, then pumped into the distribution network. The Met Station Reservoirs consists of four treated water tanks that are connected to one end of the network and located at the southwestern edge of the Township.

Figure 2: Waitangi WTP

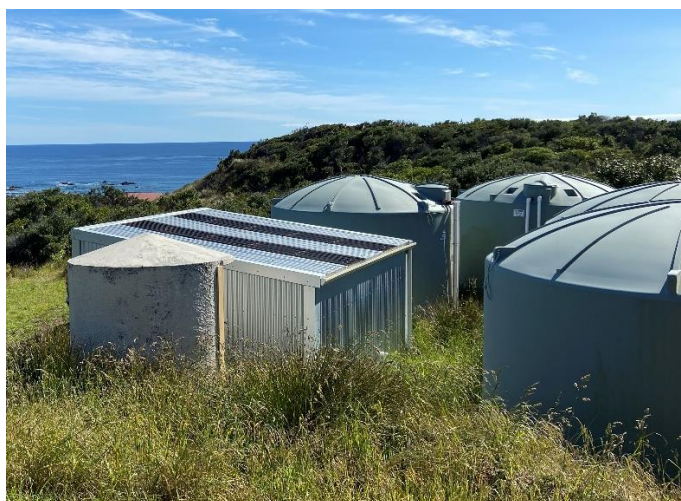
The raw water is pumped approximately 8 km from Lake Rangitai to the raw water reservoir at the Kaingaroa WTP. The water is then pumped through a multimedia filter for particulate removal and macrolite filter for pathogen reduction (albeit not recognized as a protozoal barrier under the DWSNZ). The water is softened to remove hardness and then undergoes UV disinfection before entering the treated water reservoirs and then into the reticulation network.

Figure 3: Kaingaroa WTP

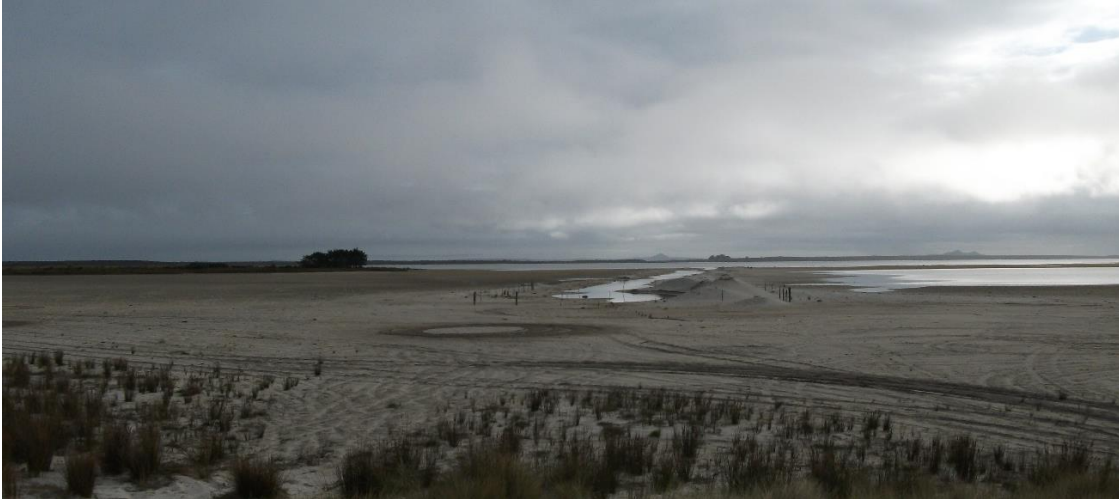
Since 2017, there has been a steady decline in rainfall at Kaingaroa and has resulted in low water levels at Lake Rangitai, which has tested the resilience of the water supply system. Anecdotally, recent lake levels are the lowest, and have occurred for the longest period, that have been seen on the island. To enable a continued raw water supply to Kaingaroa during these periods, the operator excavates a channel in the sand to maintain the flow of raw lake water to the raw water intake structure (see photo). The channel periodically needs to be reinstated (e.g., when wind and wave action causes the channel to be infilled with sand).

Figure 4: Lake Rangitai at low water level

A new Kaingaroa raw water intake, pipeline and pump was designed to extend it into deeper water at Lake Rangitai, well beyond the island that is in the background of both Figures 4 and 5. The pipe materials and fittings have been purchased and are on-island; however, the lake level rose before the pipeline could be installed. The on-shore works (i.e., pump and fittings) have been completed and the pipeline will be installed when the lake level recedes, and anticipated to be this summer (2022/23).

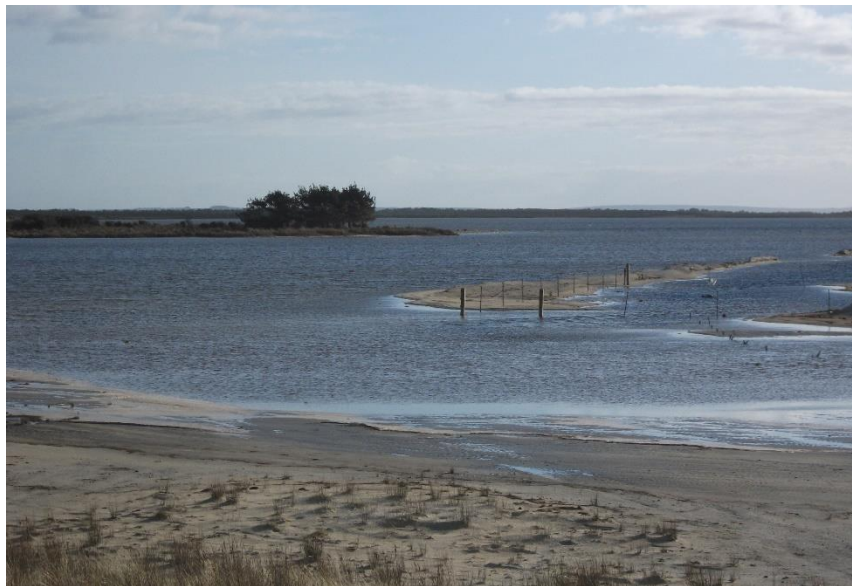
Figure 5: Lake Rangitai at high water level

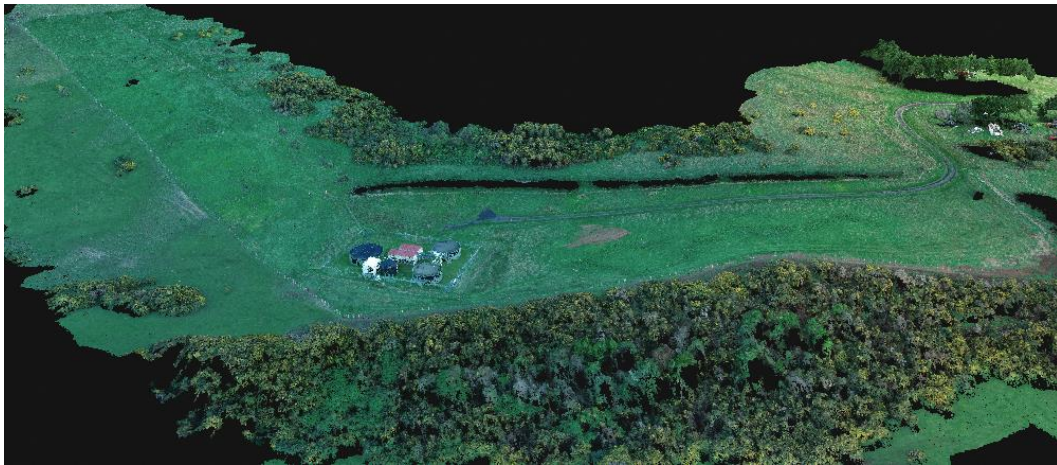
The O&M Contractor presented an opportunity to complete a drone based aerial survey. The surveying team was visiting the Chatham Islands to complete roading works. Cost sharing terms were agreed, a technical specification was developed quickly, and permissions were obtained from neighbouring property owners to survey the WWTP site. The survey data has been instrumental for the design of the Balance Tank, remotely developing the construction methodology with the O&M Contractor, and the discharge consent variation.

Figure 6: Waitangi WWTP site drone survey

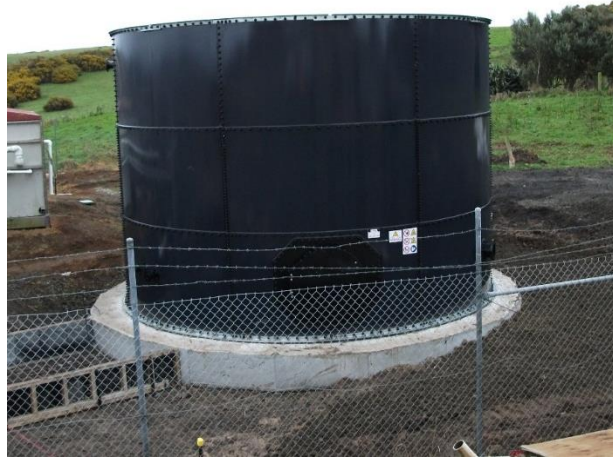
A single glass-fused bolted steel tank, with the same combined operating volume, was selected to replace the two existing Balance Tanks due to its durability and ease of construction on-site. A standard tank design was selected to minimise both design inputs and delivery times. Open channels of communication were quickly formed between the Engineer, Supplier, and O&M Contractor. When site specific piping conflicts were discovered while the tank was being fabricated, the Team was able to work quickly and collaboratively to agree on solutions that could be implemented on-site. The Team held several meetings to confirm a construction schedule, roles and responsibilities, and ensure that all the necessary resources were available in Waitangi for the construction of the tank.

The site-specific investigations, design, and enabling works necessary to accommodate the new tank was completed in parallel with the tank manufacturing and shipping stages. This was done to fast track the schedule as much as possible and to mitigate shipping delays. Several works including the geotechnical investigations, design of the ground improvement works, relocation of the site boundary fence, demolition of the existing tank, and enabling works were scheduled and completed in advance of the delivery of the tank. All necessary materials (e.g., concrete mix, granular fill) was coordinated to be available on the Chatham Islands prior to tank construction. Design work was necessary relocate the existing screen to accommodate the new hydraulic grade line, and the Team took the opportunity to improve the Balance Tank pump arrangement and removal system.

Figure 7: Newly constructed Balance Tank

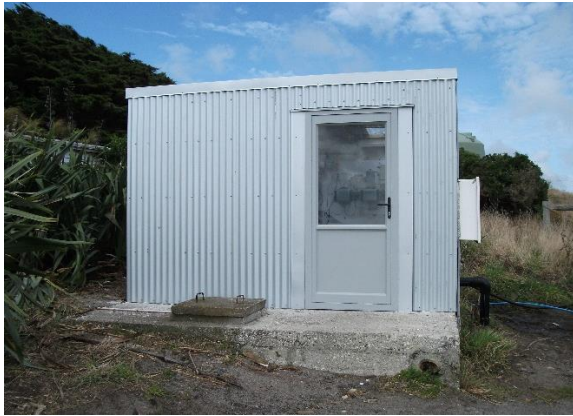
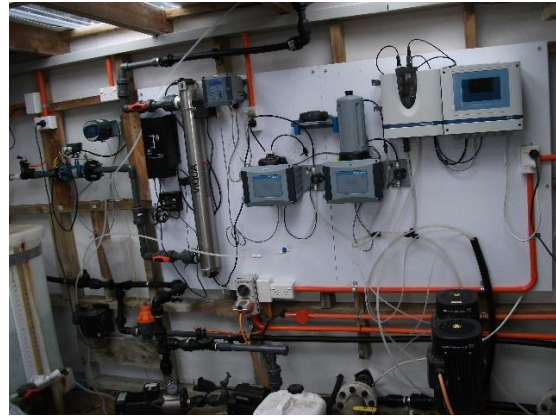
At the Waitangi WTP, new electronic flowmeters, raw and treated water online turbidimeters, and an online FAC/pH analyser were added to monitor the performance of the WTP. The two existing UV disinfection units were replaced with a new UV reactor; it is the same as the one at the Kaingaroa WTP. Commonality between the plants improves their serviceability by visiting contractors and minimises the number of different spare parts (i.e., lamps, sleeves, ballast) that need to be stored on the island.

Replacing the roof and siding of the WTP was necessary to ensure that all the equipment was adequately protected from both the elements and possible vermin, as well as minimise the risk of contaminating the water supply. The local builder to was engaged to complete the work with excellent results.

Figure 8: Waitangi WTP following upgrade
